Fire Risk Assessment

West Central Apartments, 1-35

Version 7

30 September 2024

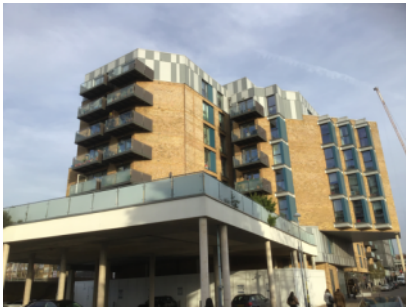
Underside of private balconies

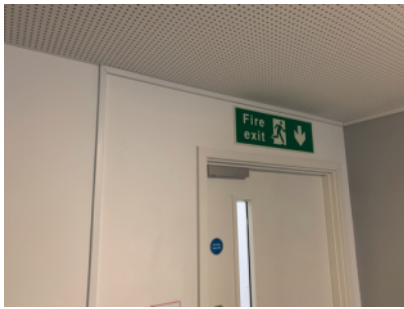
Example of PVCu cable conduit over staircase door.

2	Fire Prevention	Electrical	<p>There is electrical cabling present in common parts, and across the tops of common doorways which is suspended within PVCu conduit. A requirement introduced in 2015 in BS 7671 which covers electrical installations in the UK, states that all new wiring systems to use metal, rather than plastic, to support cables in escape routes, to prevent their premature collapse in the event of a fire.</p> <p>Version 5. 27/9/22 This task is not complete.</p> <p>.... Version 7 - FRA carried out on 30/9/24 This re the same as the previous FRA.</p>	Advisory	Identified
---	-----------------	------------	---	----------	------------

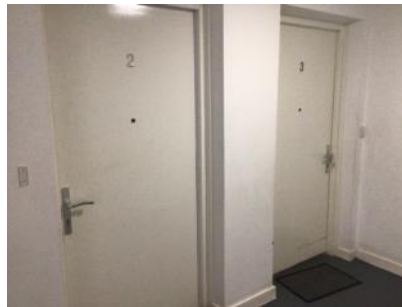
Flat entrance doors are of similar
appearance

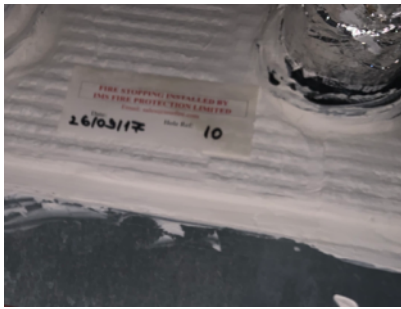
There has been a programme of fire stopping carried out in the building and in many cases this was found to be of a good standard. However, in electrical riser cupboards on all floors there is fire stopping installed with many gaps and cavities which would not provide the required fire resistance. This is also the case in the ground floor plant room. Given the number of penetrations in the building which require fire stopping it is recommended to conduct a full fire stopping survey of this building.

Example of fire stopping certification label - IMS Fire Protection Ltd 2017

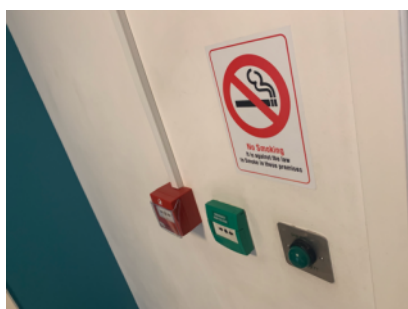
Manual call points are located at storey exits.

Manual call points located at each floor exit

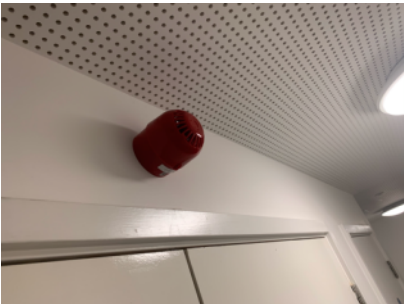
Sounders located in common areas

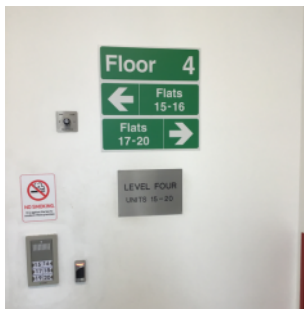
Clear wayfinding signage has been provided

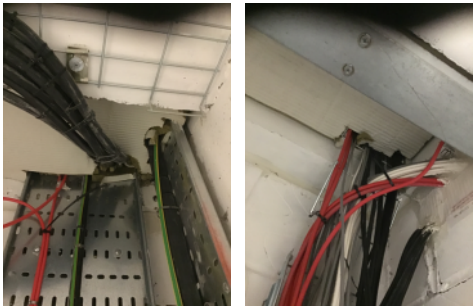
Task 1

Source Version	1
Category	Escape Routes & Fire Spread
Sub Category	Construction and Glazing
Action Required	<p>Provide fire stopping around cable penetrations in the following locations:</p> <p>Within the electrical risers, located within corridors to flats, there has been some fire stopping installed, although it is inadequate with holes and gaps.</p> <p>Version 4 - This task is still outstanding.</p> <p>Version 5. 27/9/22 This task is not complete.</p> <p>....</p> <p>Version 7 - FRA carried out on 30/9/24 This work is still to be completed.</p>
Priority	Medium
Status	Identified
Owner	Customer Homes
Due Date	21 November 2020

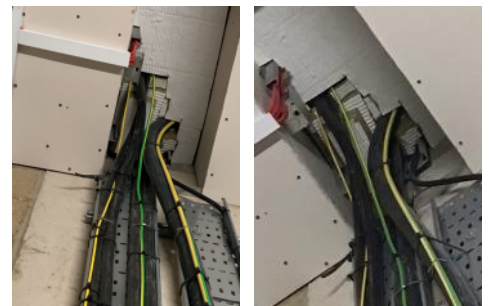
Task 3

Source Version	1
Category	Escape Routes & Fire Spread
Sub Category	Construction and Glazing
Action Required	<p>Provide fire stopping around cable and pipe penetrations in the following locations:</p> <p>Within the plant room on the ground floor there are numerous pipe and cable penetrations which have not been adequately fire stopped.</p> <p>Version 5. 27/9/22 This task is not complete. Version 7 - FRA carried out on 30/9/24 This work is still to be completed. (This room is also used as an office for the Waking Watch).</p>
Priority	Medium
Status	Identified
Owner	Customer Homes
Due Date	21 November 2020

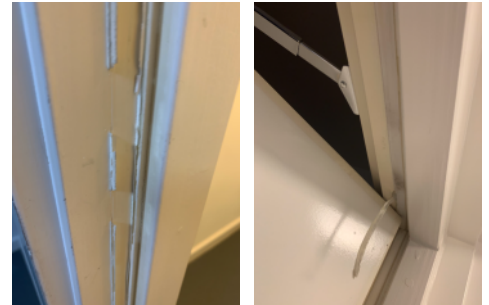
Task 4

Source Version	1
Category	Escape Routes & Fire Spread
Sub Category	Fire Doors
Action Required	Neoprene type smoke seals have been installed in many of the fire resisting doors in common areas, and in flat front doors. These do not wear well and there are many which are already damaged or missing. A task has been generated, however with the presence of a common fire detection and alarm system provided in the building this task has been entered as advisory.
	Version 5. 27/9/22 It is noted that many of these seals are damaged. Version 7 - FRA carried out on 30/9/24 This remains the same, with a number of damaged / worn seals observed.
Priority	Advisory
Status	Identified
Owner	Customer Homes
Due Date	21 November 2022

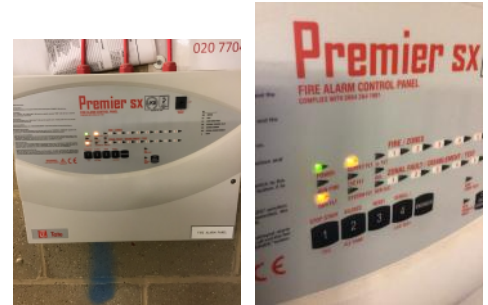
Task 6

Source Version	4
Category	Detection & Warning
Sub Category	Control Equipment
Action Required	<p>The fire alarm panel in the main plant room is in a fault condition. The panel should be serviced by an engineer.</p> <p>Version 5. 27/9/22 The fire panel remains in fault. This task is not complete.</p> <p>....</p> <p>Version 7 - FRA carried out on 30/9/24 This remains the same as the previous FRA, with the panel showing Gen Fault and Supply Fault.</p>
Priority	High
Status	Identified
Owner	Customer Homes
Due Date	08 February 2022

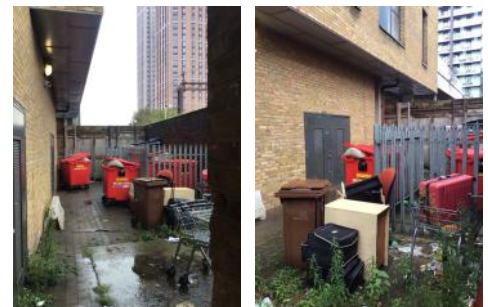
Task 7

Source Version	4
Category	Fire Prevention
Sub Category	Arson
Action Required	<p>Do not keep bins adjacent to the building, they should be secured in the compound provided and clear the rubbish from the rear yard to reduce the risk of malicious ignition.</p> <p>Version 5. 27/9/22 This task is not complete.</p> <p>....</p> <p>Version 7 - FRA carried out on 30/9/24 This remains the same as the previous FRA.</p>
Priority	High
Status	Identified
Owner	Neighbourhood Services
Due Date	08 February 2022
