Fire Risk Assessment 12-28 Zoffany Street Version 5 13 September 2024

Next Assessment Due: 30 September 2025 Risk Score: Tolerable Risk Assessor: David Lloyd

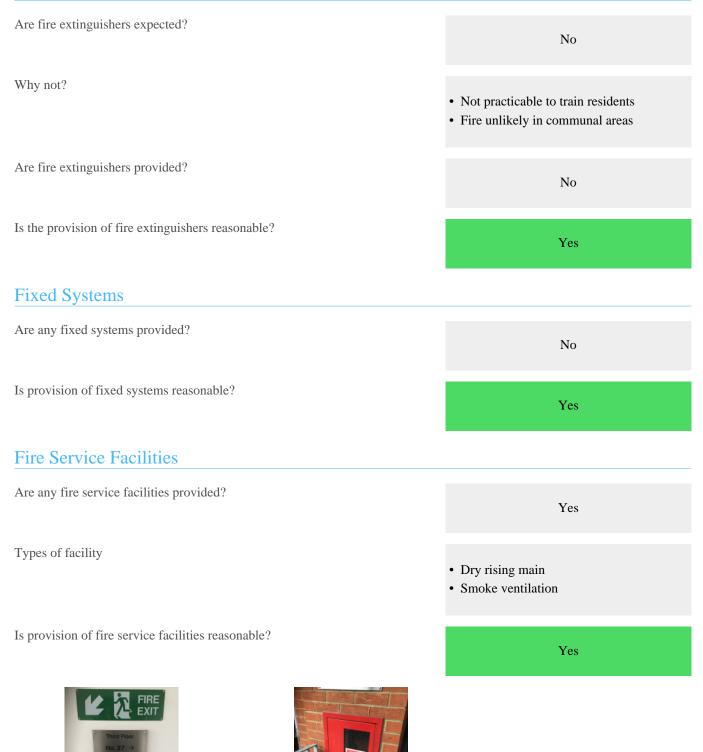
Floors are clearly identified

Dry riser inlet, adjacent main entrance door.
