Fire Risk Assessment

Shoreditch Court

Version 5

9 October 2023

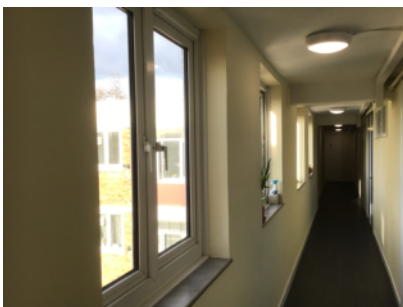
Openable windows on corridors

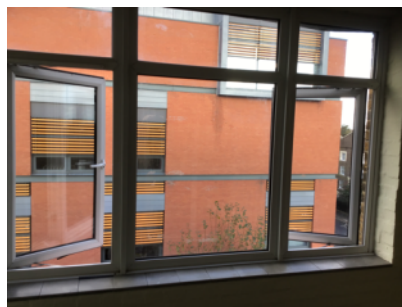
Openable windows in the staircase

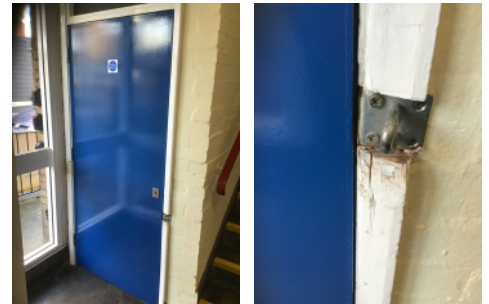
Task 1

Source Version	2
Category	Escape Routes & Fire Spread
Sub Category	Fire Doors
Action Required	Repair the following doors to an FD30S standard: Basement door, ground floor. There is damage to the door frame. Version 4. 22/9/22 This task is not complete.
Priority	Medium
Status	Identified
Owner	Customer Homes
Due Date	14 May 2021

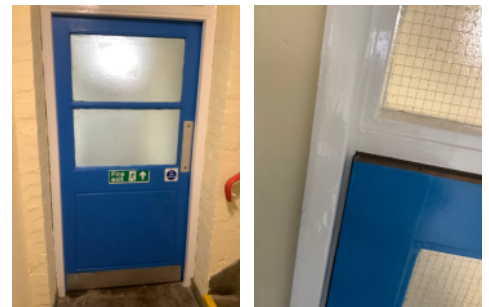
Task 6

Source Version	3
Category	Escape Routes & Fire Spread
Sub Category	Fire Doors
Action Required	Re-hang the following doors to enable the doors to easily close: Staircase door, ground floor, leading to the laundry. Does not fully close on the action of the self closing device. Version 4. 22/9/22 This task is not complete.
Priority	Medium
Status	Identified
Owner	Customer Homes
Due Date	13 June 2022

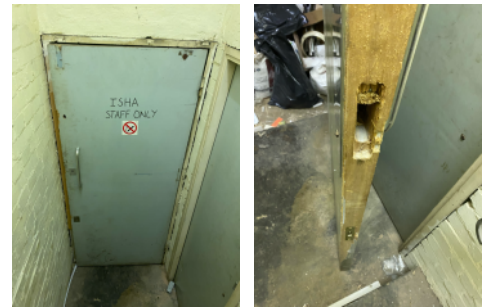
Task 7

It was possible to access the basement area during this version of the fire risk assessment inspection. It was noted that FD60 door leading into the plant room/water tank room in the basement is damaged and would not afford the required standard of fire resistance. It is recommended to repair this door to an FD60S standard, or replace it with one which would meet that standard.

Source Version	3
Category	Escape Routes & Fire Spread
Sub Category	Fire Doors
Action Required	The FD60 door leading into the plant room/water tank room in the basement is damaged and would not afford the required standard of fire resistance. It is recommended to repair this door to an FD60S standard, or replace it with one which would meet that standard.
	It was also noted that there are gaps around the frame of this door which require fire stopping.
	Version 4. 22/9/22 This task is not complete.
Priority	Medium
Status	Identified
Owner	Customer Homes
Due Date	13 June 2022

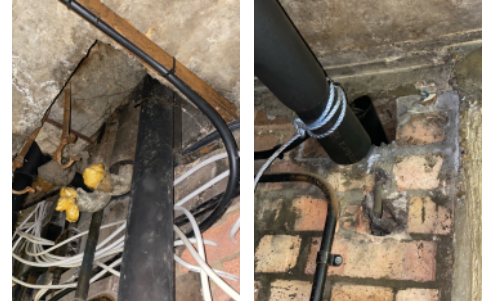
Task 8

It was possible to access the basement area during this fire risk assessment inspection. It was noted that there are numerous cable and pipe penetrations from the plant room/water tank room which require fire stopping.

Source Version	3
Category	Escape Routes & Fire Spread
Sub Category	Construction and Glazing
Action Required	It was noted that there are numerous cable and pipe penetrations from the plant room/water tank room which require fire stopping.
	Version 4. 22/9/22 This task is not complete.
Priority	High
Status	Identified
Owner	Customer Homes
Due Date	13 March 2022

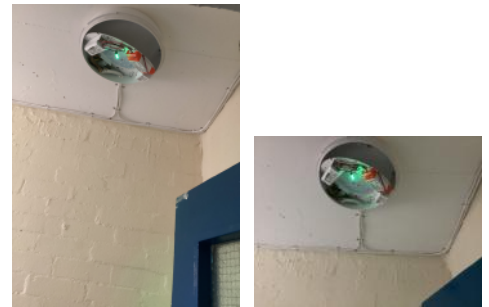
Task 11

There is an emergency lighting unit which requires repair in the ground floor refuse chute lobby.

Source Version	4
Category	Emergency Lighting
Sub Category	Emergency Lighting
Action Required	Repair the emergency light in the following locations: chute exit ground floor
Priority	Medium
Status	Identified
Owner	Customer Homes
Due Date	23 March 2023
