## Fire Risk Assessment

### Spring Villa

Version 5

3 October 2023

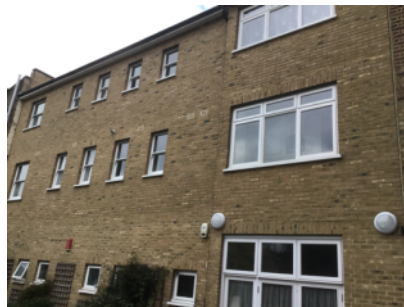
External walls-rear of the building.

The southern section of the building is of the original brick/mortar construction with render applied on the ground floor level only. At some point the northern end of the building was extended, however the external walls in this part of the building is also of brick/mortar construction with no additional external wall system is fitted.

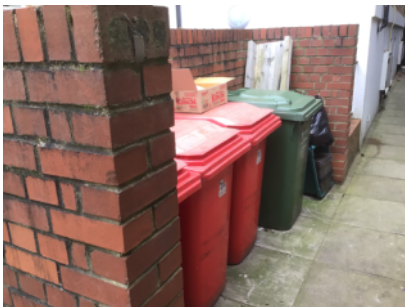
Bins are located in the rear garden is suitable distance away from the building.

Bins located in the rear garden, at a suitable distance from the building

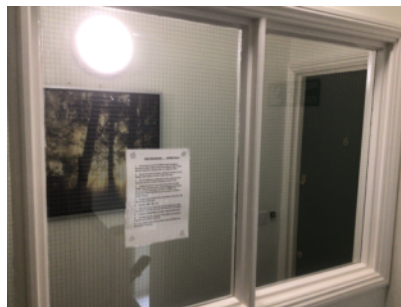
Georgian wired glazing in corridors.

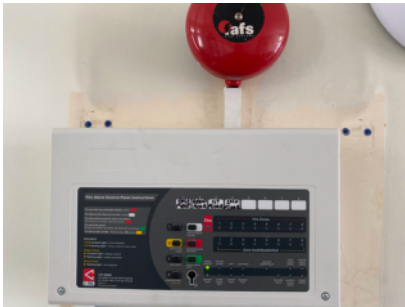
It is evident that since the previous fire risk assessment a new fire alarm control panel has been installed in the ground floor lounge area.

Recently installed fire alarm control panel

VERSION 3: Access was gained into flat 10, where it was noted this flat has a fire alarm provided to BS5839-6 Category LD3 standard . It is therefore reasonable to assume that the recent upgrading of the fire alarm panel has not included upgrading the fire alarms provided within the flats to the required standard.

The fire alarm provision in these flats is below that recommended by national guidance (BS5839-6 Category LD1), as noted in the previous FRA. It may be reasonably assumed this is also the case for the flats which could not be accessed. It should be ensured the fire alarm provision in all flats meet the recommendations of BS5839-6 LD1 standard.

The SSO on site could not confirm the cause and effect of either the common fire alarm, or the fire alarms provided in flats. It is recommended that definitive confirmation of the category and standard of fire alarms is ascertained from the fire alarm installer or servicing engineers, and a gap analysis conducted against the recommendations for a building of this type and occupancy type within national guidance - and extend or upgrade the fire alarm accordingly
