### **Fire Risk Assessment**

### **Beaver House**

Version 3

3 October 2023

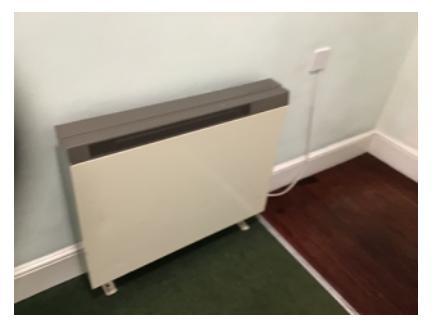
There are electrical storage heaters in common areas on each floor level. These appear in good condition with no apparent damage visible.

Storage heaters used in common areas

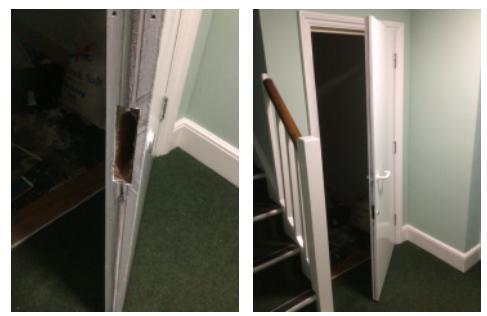
Source Version	2	
Category	Escape Routes & Fire Spread	
Sub Category	Fire Doors	
Action Required	Repair the following doors to an FD30S standard:	
	Cupboard at base of stairs, basement level.	
	03/10/22023 This task remains outstanding.	
Priority	Medium	
Status	Identified	
Owner	Customer Homes	
Due Date	10 September 2021
