Fire Risk Assessment 1-27 Lyme Grove House Version 9

30 September 2024

Next Assessment Due: 30 September 2025 Risk Score: Tolerable Risk Assessor: Mark Simmons

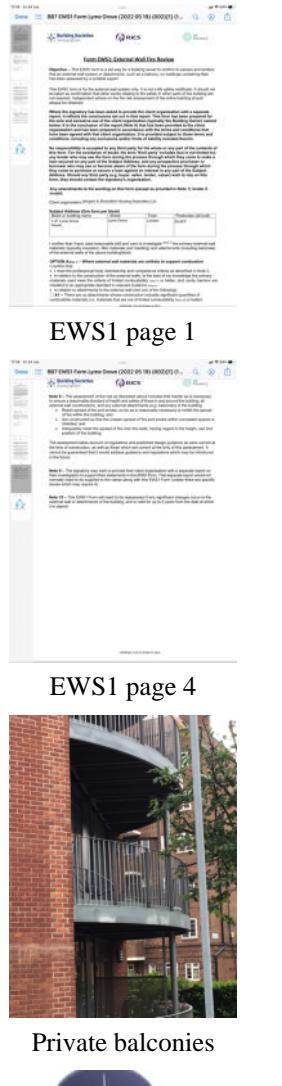
Combustibles noted on private balconies

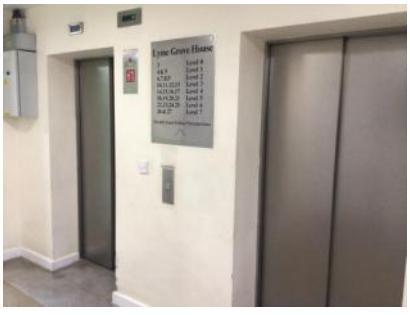
Lifts provided

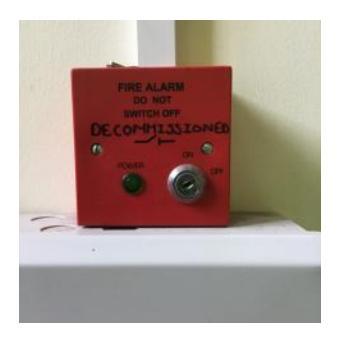
It is noted that the temporary interim common fire alarm has been switched off. It is recommended that this system is reconfigured to be a whole building evacuation alarm for the Fire Service to use if there was a serious fire in a flat, this is in accordance with the latest NFCC guidance.

Decommissioned Part 1 system

It is recommended that the temporary common fire alarm which is now decommissioned is adapted to become a full building evacuation alarm for the fire service to use if there was a serious fire in a flat.

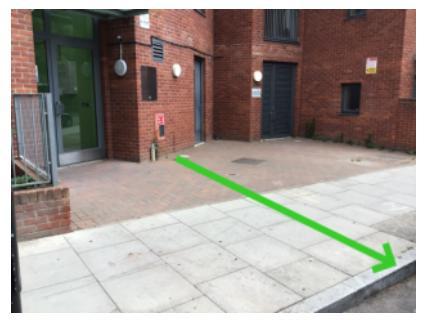
Dry riser inlet approximately 6m from kerbside

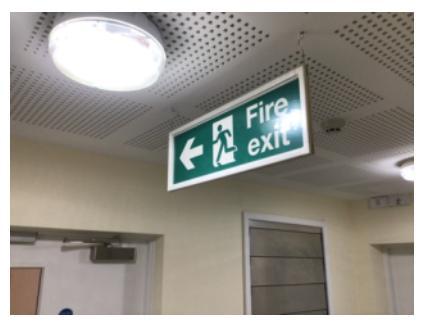
Escape route signage provided

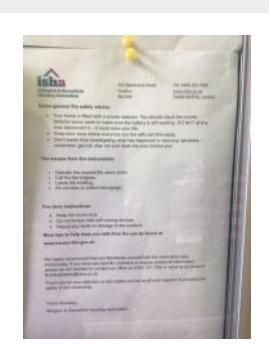
Fire safety information displayed - page 2
