Fire Risk Assessment

1-20 St Mary's House

Version 2

4 December 2020

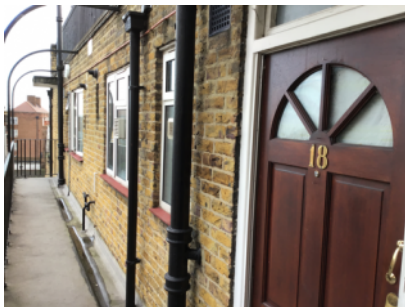
There are fanlights in flat entrance doors, and windows on common balconies. All of which are located above 1.1m from the balcony deck and therefore are not required to be fire resisting glazing.

Fanlights and window glazing located above 1.1m

All glazing on common balconies above 1.1m

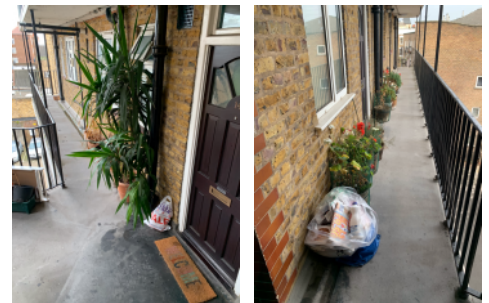
Task 3

There are a number of items located in the common areas (mainly plant pots), which whilst currently do not present a significant risk, these areas should be monitored to ensure they do not build up.

Source Version	1
Category	Escape Routes & Fire Spread
Sub Category	Ease of Use
Action Required	Although the amount of items currently in escape routes is not unreasonable, routes should be monitored to ensure that a build-up of items does not impede escape.
Priority	Low
Status	Identified
Owner	Neighbourhood Services
Due Date	6 January 2022
