Fire Risk Assessment

Robinson Court

Version 2

7 December 2020

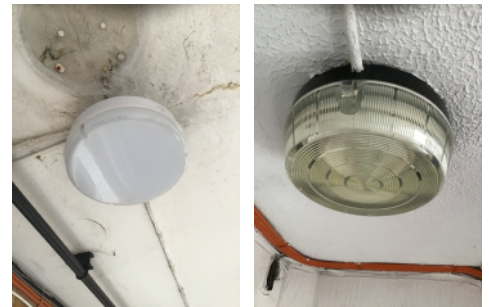
Emergency lighting is provided in the staircases and on balconies, however, there appears to be numerous lighting units which are not showing a charging light.

Priority	Medium
Status	Identified
Owner	Neighbourhood Services
Due Date	7 January 2021

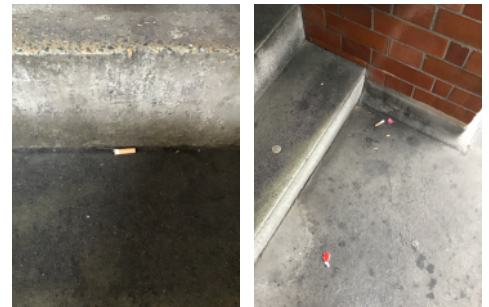
Task 8

"No Smoking" signage is only provided in one staircase and there is evidence of smoking taking place in the common parts of the building.

Source Version	1
Category	Fire Prevention
Sub Category	Smoking
Action Required	A no smoking policy should be enforced in the premises.
Priority	Medium
Status	Identified
Owner	Neighbourhood Services
Due Date	7 January 2021

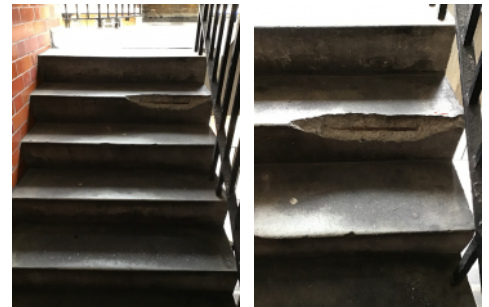
Task 10

Between the second and third floors, the stair nosings on the stairs leading to flats 29-31 require repair.

Source Version	1
Category	Escape Routes & Fire Spread
Sub Category	Ease of Use
Action Required	The stair nosings in the following locations should be repaired: Between second and third floors, (leading to flats 29-31)
Priority	Low
Status	Identified
Owner	Customer Homes
Due Date	7 January 2022
