Fire Risk Assessment

Shakespeare House

Version 5

21 April 2023

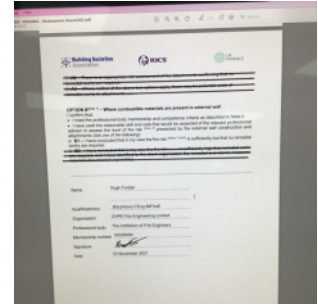
An EWS1 a form has been completed with a B1 rating.

Page 2 of EWS1 form

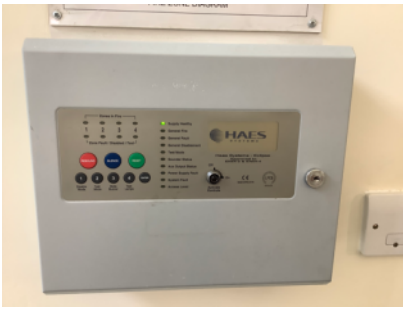
VERSION 4: the panel was noted as being in a “healthy” condition and therefore this task has been completed,

Control panel, showing “Healthy” condition

The fire alarm panel is in a fault condition. The panel should be serviced by an engineer.

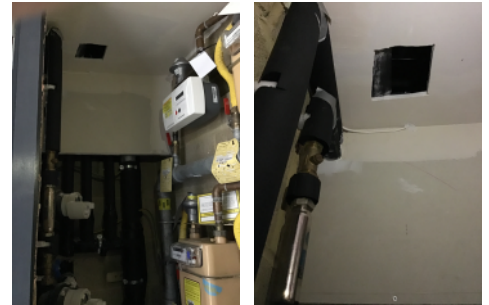
Task 4

There is a small amount of combustible items in the electrical cupboard ground floor, and within the gas riser cupboard 1st floor.

Source Version 1
Category Fire Prevention
Sub Category Housekeeping
Action Required The storage of combustible items in electrical cupboards and riser cupboards should be prohibited.
