Fire Risk Assessment

1-16 Portfleet Place

Version 4

31 August 2023

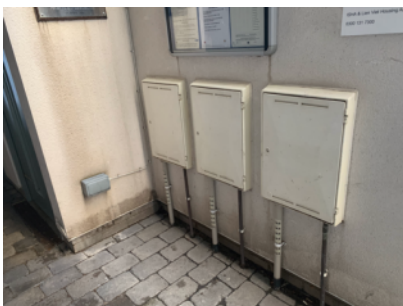
Gas meters are located in external bespoke cabinets.

Gas meter cupboards

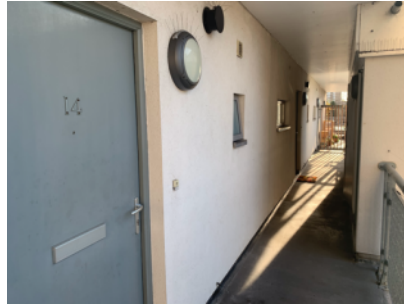
There is window glazing to flats along common balconies, however, these are above 1.1m and are therefore not required to be fire resisting.

Showing window glazing to flats - above 1.1m
