Fire Risk Assessment

1-7 Thomas Cromwell Court

Version 3

9 July 2021

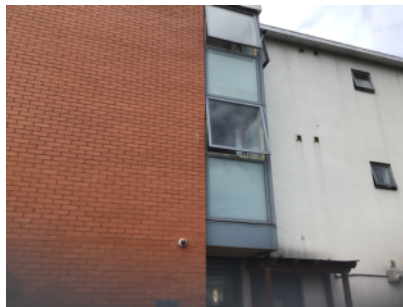
Rendered surface

External walls, part brick, part rendered.

This building is of a brick/mortar construction with a rendered finish over the majority of the external walls overall floors. The substrate to which this render has been applied cannot be confirmed within the scope of this fire risk assessment although it does appear to be directly over the brickwork.

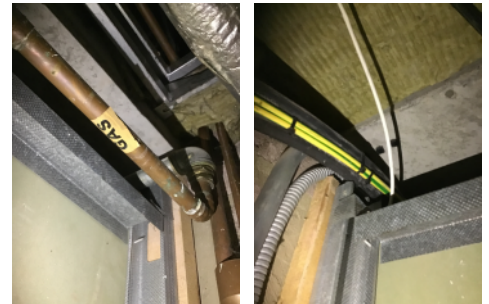
Task 1

Access into riser cupboards revealed that there is no fire stopping installed around pipe and cable penetrations from the cupboards into common areas and flats. It is recommended to fire stop all riser cupboards to maintain effective fire separation between the cupboards, and common areas and flats.

Source Version	1
Category	Escape Routes & Fire Spread
Sub Category	Construction and Glazing
Action Required	Provide fire stopping around pipe and cable penetrations in the following locations: All riser cupboards.
Priority	Medium
Status	Identified
Owner	Customer Homes
Due Date	22 February 2021

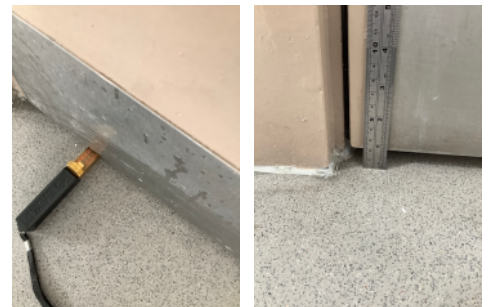
Task 4

Threshold gap, 20mm, first floor lobby door

Threshold gap, 20mm, second floor lobby door

Source Version	2
Category	Escape Routes & Fire Spread
Sub Category	Fire Doors
Action Required	Re-hang the following doors to reduce the gaps around the doors: Lobby doors were noted to have threshold gaps in excess of 20 mm and should be rehung to reduce these gaps. 31/08/23 This task is still outstanding.
Priority	Medium
Status	Identified
Owner	Customer Homes
Due Date	7 January 2022
