**Fire Risk Assessment**

**1-9 Wilton Place**

Version 3

7 August 2023

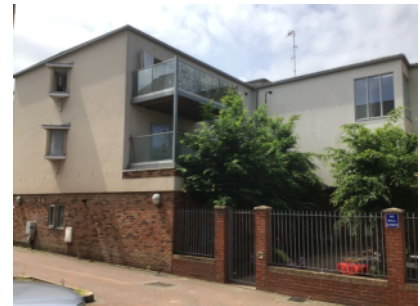
External walls, end elevation

Masonry external walls, rendered over the 1st and 2nd floor. It is not known to what material this render has been applied to, or the substrate beneath it as this was a non-intrusive fire risk assessment.

Attention is drawn to the Ministry of Housing, Communities & Local Government Consolidated Advice Note for building owners of multi-storey, multi-occupied residential buildings, dated January 2020. The Advice Note recommends that building owners should consider the risk of external fire spread as part of the fire risk assessment for multi-occupied residential buildings. Consideration has been given to this matter within this fire risk assessment. The Advice Note further recommends the assessment of the fire risks of any external wall system, irrespective of the height of the building.

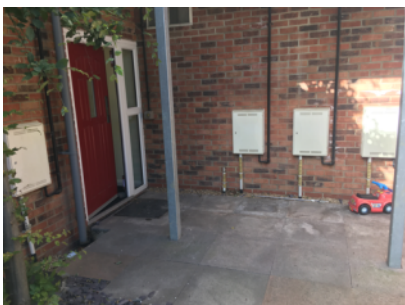
Gas meters are located externally and not in common areas.

Gas meters located externally

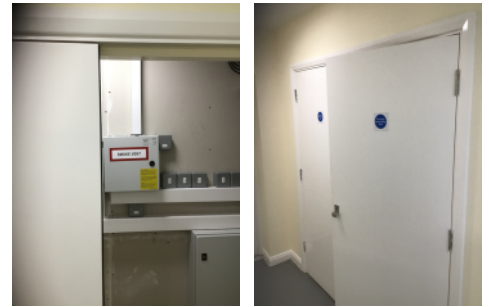
Source Version	1
Category	Signs & Notices
Sub Category	Other Signage
Action Required	Provide signage to indicate the location of the smoke vent controls, within the riser cupboard on the 1st floor.
Priority	Low
Status	Identified
Owner	Neighbourhood Services
Due Date	1 July 2021

Provide signage to indicate the location of the smoke vent controls, within the riser cupboard on the 1st floor.

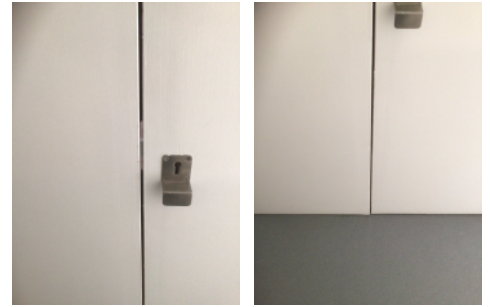
Source Version	2
Category	Escape Routes & Fire Spread
Sub Category	Fire Doors
Action Required	Re-hang the following doors to reduce the enter gap on the riser doors adjacent flat 9.
Priority	Medium
Status	Identified
Owner	Customer Homes
Due Date	14 December 2021
