Fire Risk Assessment

12-28 Zoffany Street

Version 4

3 October 2023

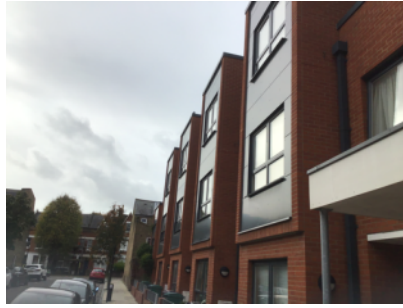
External wall system installed on NE elevation of building

Brick/mortar external walls with an unidentified material window rainscreen

Brick and mortar external walls. There is an external wall system installed at the NE end of the building. The material and composition of this wall system cannot be identified within the scope of this Fire Risk Assessment. There are also window rainscreens installed, again, the material and composition of these is unknown and should be confirmed.

Assessment of the fire risks of external walls and any cladding are excluded from the scope of this current fire risk assessment, as this is outside our expertise. (6) Accordingly, it is strongly recommended that you obtain advice from qualified and competent specialists on the nature of, and fire risks associated with, the external wall construction, including any cladding, of this building.

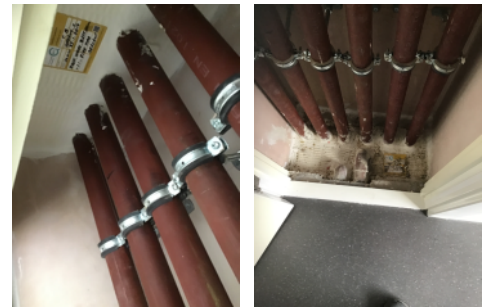
Task 3

The gas riser has been fully fire stopped, including at each level through the riser.

Source Version	3
Category	Fire Prevention
Sub Category	Gas
Action Required	Fire stopping within gas risers should ensure that pipe penetrations into the common parts of the building from the riser are fire stopped, but it should be ensured that the protected shaft remains ventilated as per ADB Guidance. (Approved Document B Volume 1, 2019 edition, paragraph 7.28)
Priority	Medium
Status	Identified
Owner	Customer Homes
Due Date	28 April 2021

Fire stopping within gas risers should ensure that pipe penetrations into the common parts of the building from the riser are fire stopped, but it should be ensured that the protected shaft remains ventilated as per ADB Guidance.

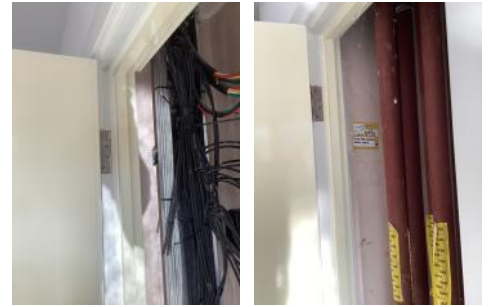
Task 5

Source Version	3
Category	Escape Routes & Fire Spread
Sub Category	Fire Doors
Action Required	Replace the intumescent strips with combined intumescent strips and smoke seals on the following doors: Gas and water riser cupboards. These cupboards are fire stopped to a high standard, have no ignition sources, so this task is afforded a low priority.
Priority	Low
Status	Identified
Owner	Customer Homes
Due Date	28 October 2021

Replace the intumescent strips with combined intumescent strips and smoke seals on the Gas and water riser cupboard doors. These cupboards are fire stopped to a high standard, have no ignition sources, so this task is afforded a low priority.

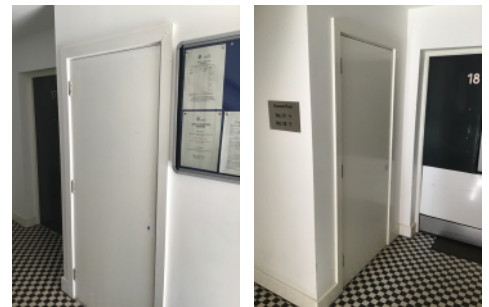
Task 6

Source Version	2
Category	Signs & Notices
Sub Category	Fire Door Signage
Action Required	Provide “Fire Door Keep Locked” signage on the BT Riser door and Water riser door on the ground floor. VERSION 3: This task has not been completed.
Priority	Low
Status	Identified
Owner	Neighbourhood Services
Due Date	1 September 2021
