Fire Risk Assessment

12 Ainsworth Road

Version 5

7 November 2023

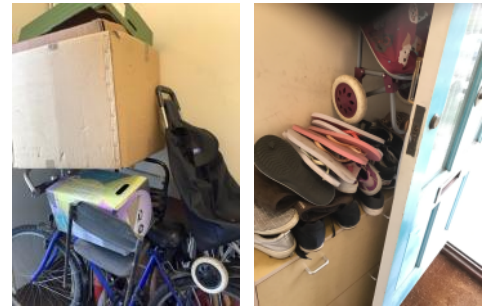
Task 1

There was a significant volume of combustible materials found in the entrance hall.

Source Version	1
Category	Fire Prevention
Sub Category	Housekeeping
Action Required	The storage of combustible items in escape routes should be prohibited. VERSION 2: The entrance hallway still contains a significant amount of combustible items. These should be removed. VERSION 3: The entrance hallway still contains a significant amount of combustible items. These should be removed. VERSION 4: The entrance hallway still contains a significant amount of combustible items. These should be removed. 07/11/2023 This task remains outstanding.
Priority	High
Status	Identified
Owner	Customer Homes
Due Date	5 February 2019

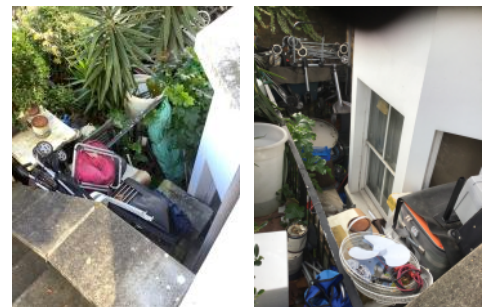
Task 5

However, there is a large quantity of combustible items stored directly against the front of the property, directly against glazed windows. Any fire occurring here would undoubtedly affect the building as a whole. This area should be cleared.

Source Version	2
Category	Fire Prevention
Sub Category	Arson
Action Required	Do not store combustible materials adjacent to the building. There is a large quantity of combustible items stored directly against the front of the property, directly against glazed windows. Any fire occurring here would undoubtedly affect the building as a whole. This area should be cleared. VERSION 3: This has not yet been cleared and a large quantity of combustible items still remain. VERSION 4: This has not yet been cleared and a large quantity of combustible items still remain. 07/11/2023 This task remains outstanding.
Priority	Medium
Status	Identified
Owner	Neighbourhood Services
Due Date	7 October 2020

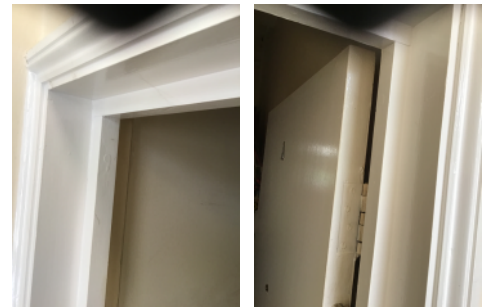
Task 7

Access was gained into flat A which has an entrance door fitted to FD30 SC (notional) standard, however the internal doors are not fire resisting. It has a PERKO type self closing device which appeared to operate correctly . However, it has no intumescent strips or cold smoke seals fitted.

Source Version 2
Category Escape Routes & Fire Spread
Sub Category Fire Doors
Action Required Install intumescent strips and smoke seals on the following doors:

Entrance door to Flat A.

It may be reasonably assumed that the entrance door to flat B does not have intumescent strips and smoke seals installed either. These should be installed in both doors.

Both doors have 1" door stops provided, and therefore this task is assessed as a low priority.

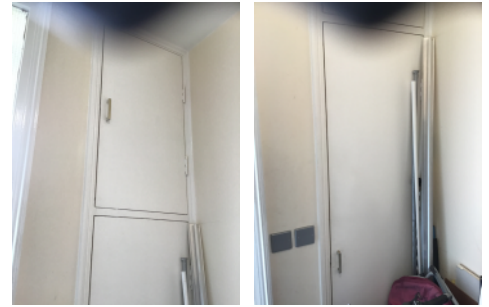
Task 8

The electrical cupboard is not provided with a 'Fire Door Keep Locked' sign.

Action Required The following doors should be kept locked shut:

Electrical cupboard doors should be provided with locks and kept locked shut.
