Fire Risk Assessment

14-19 Bramble Close

Version 3

7 September 2023

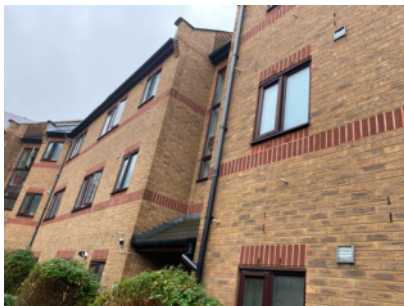
External walls - front elevation

External walls appear to be of brick and mortar construction with no combustible external wall system evident.

Assessment of the fire risks of external walls and any cladding are excluded from the scope of this current fire risk assessment, as this is outside our expertise. (6) Accordingly, it is strongly recommended that you obtain advice from qualified and competent specialists on the nature of, and fire risks associated with, the external wall construction, including any cladding, of this building.

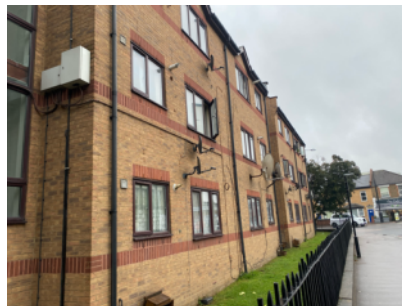
External walls - rear elevation (road side)
