Fire Risk Assessment

18-23 Wilton Place

Version 3

7 August 2023

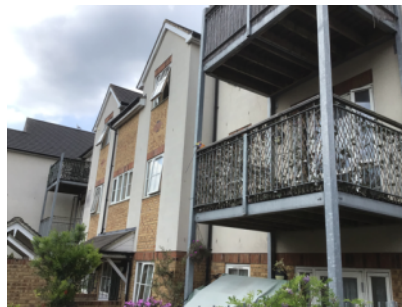
External walls, end elevation

External wall details

Masonry external walls (part rendered)

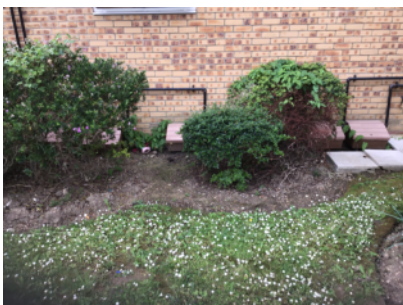
Gas meters are located externally and not in common areas.

Gas meters located externally

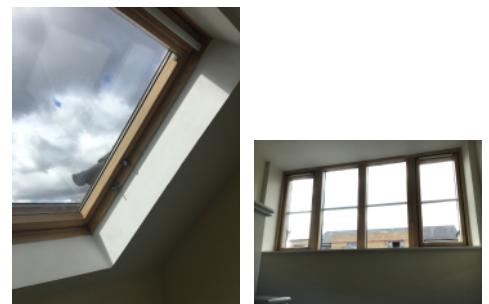
Task 5

The velux type window AOV on the 2nd floor appears to have no opening mechanism. The smoke ventilation was tested via a the ground floor manual actuator, however no AOVs operated in the common staircase. The system should be tested as soon as possible and repaired as necessary to ensure it is fully operational at all times.

Window AOV appears defective

Source Version	1
Category	Escape Routes & Fire Spread
Sub Category	Smoke Ventilation
Action Required	Repair the smoke vents in the following locations: All Window AOVs in staircase.
Priority	Critical
Status	Identified
Owner	Customer Homes
Due Date	1 July 2020

5	Escape Routes & Fire Spread	Smoke Ventilation	Repair the smoke vents in the following locations: All Window AOVs in staircase.	Critical	Identified
6	Signs & Notices	Other Signage	Provide fire action notices which confirm the action to take in the event of fire.	Medium	Identified
