Fire Risk Assessment

20-25 Bramble Close

Version 3

7 September 2023

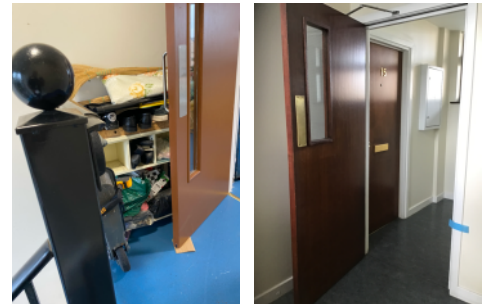
Task 1

Source Version	1
Category	Escape Routes & Fire Spread
Sub Category	Fire Doors
Action Required	Wedges should not be used to hold open fire doors. Both lobby doors, first and second floors.
Priority	High
Status	Identified
Owner	Neighbourhood Services
Due Date	12 January 2021

Both the lobby doors on the first and second floors were found to be wedged open - it is imperative that these remains closed at all times to protect the staircase in the event of a fire in any flat.

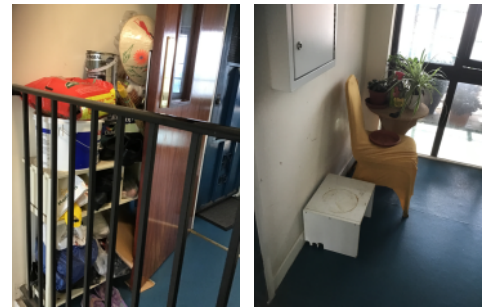
A large amount of combustible items are located on the top floor landing of the staircase and in the second floor lobby.

VERSION 2: This task has not been completed, in fact the number of items has significantly increased since the last fire risk assessment was carried out

Source Version 1
Category Fire Prevention
Sub Category Housekeeping
Action Required The storage of combustible items in escape routes and stairs should be prohibited.

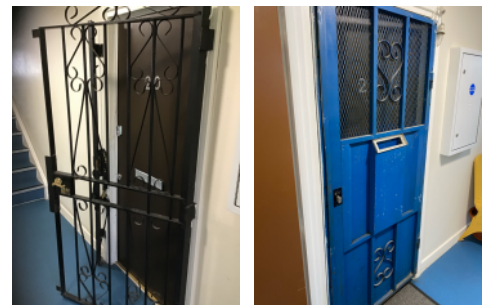
Task 4

Source Version 1
Category Escape Routes & Fire Spread
Sub Category Ease of Use
Action Required There is a security gate across the entrance doors to some flats in the building. Residents should be advised of the dangers of locked security gates in the event of a fire to ensure that they are able to exit quickly in an emergency.

There is a security gate across the entrance doors to some flats in the building. Residents should be advised of the dangers of locked security gates in the event of a fire to ensure that they are able to exit quickly in an emergency.
