Fire Risk Assessment

200 Kingsland Road

Version 3

5 October 2023

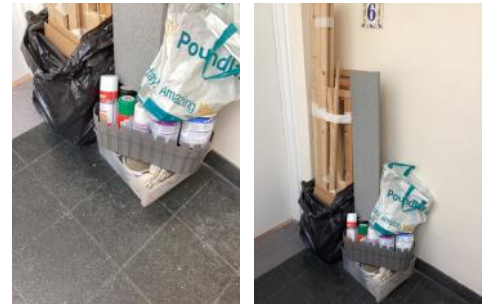
Task 1

The standard of housekeeping throughout the building was found to be unsatisfactory, with an unacceptable amount of combustible items (including tins of paint) and obstructions located in the staircase, particularly on the top floor landing.

Source Version	1
Category	Fire Prevention
Sub Category	Housekeeping
Action Required	The storage of combustible items, including paint and lubricants in the staircase should be prohibited. Directly outside flats 5 and 6.
Priority	High
Status	Identified
Owner	Neighbourhood Services
Due Date	27 January 2021

The storage of combustible items, including paint and lubricants in the staircase should be prohibited.
