Fire Risk Assessment

28 Hurst Road, Walthamstow

Version 5

13 September 2023

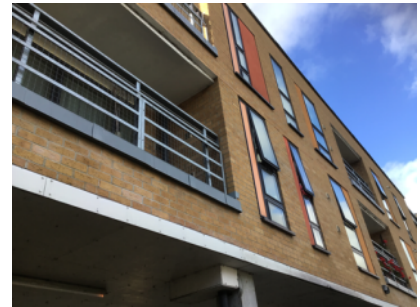
External walls - side elevation

Brick/mortar external walls. Ground floor level (undercroft carpark) is rendered.

Rear elevation external walls are rendered, the substrate to which the render has been applied cannot be confirmed within the scope of this FRA.

Assessment of the fire risks of external walls and any cladding are excluded from the scope of this current fire risk assessment, as this is outside our expertise. (6) Accordingly, it is strongly recommended that you obtain advice from qualified and competent specialists on the nature of, and fire risks associated with, the external wall construction, including any cladding, of this building.
