# Fire Risk Assessment 31 Davenant Road

Version 3

7 November 2023

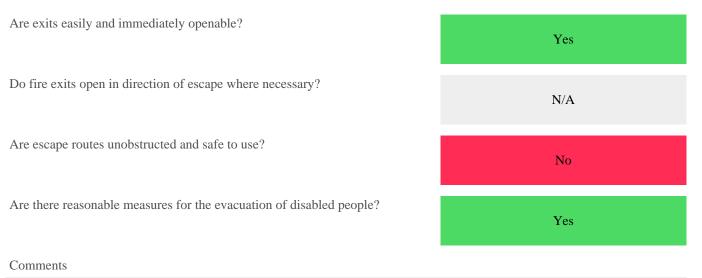
The main entrance door does not require the use of a key to escape.

A bicycle and other obstructions we are located in the entrance hallway directly outside of flat A. These should be removed to ensure the escape routes are clear from both flats.

Main entrance door lock can be opened from the inside without a key.

Source Version	2	
Category	Escape Routes & Fire Spread	
Sub Category	Ease of Use	
Action Required	A bicycle and other obstructions we are located in the entrance hallway directly outside of flat A. These should be removed to ensure the escape routes are clear from both flats.	
Priority	Medium	
Status	Identified	
Owner	Neighbourhood Services	
Due Date	21 July 2021
