Fire Risk Assessment

4 Tufnell Park Road

Version 3

12 October 2023

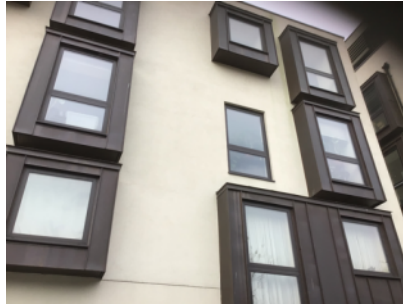
External walls - front elevation

The external facade appears to be a render over insulation board.

There is a metallic rain screen covering sections of the front face of the building and around window openings.

There is some decorative gridwork which appears to be of timber construction attached to the external facade of the third and fourth floors

Whilst this building is not over 18 m, it should be considered to conduct an intrusive examination of the external walls to ensure that they meet the requirements of the building regulations regarding external fire spread.

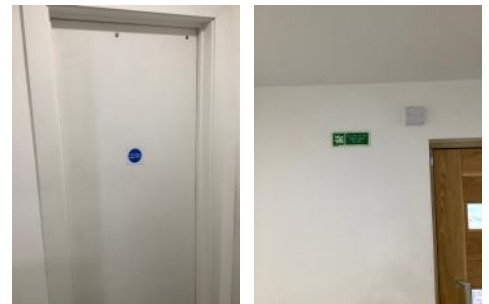
Task 2

Source Version	1
Category	Signs & Notices
Sub Category	Other Signage
Action Required	Remove the following redundant or incorrect signage; The break glass sign in the ground floor foyer. The Fire Door Keep Closed signs on the smoke vent doors. 12/10/2023 This task is outstanding.
Priority	Advisory
Status	Identified
Owner	Neighbourhood Services
Due Date	26 March 2022

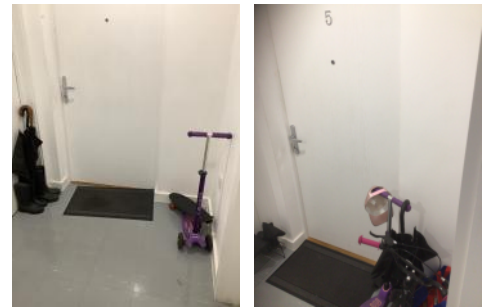
Task 5

Source Version	2
Category	Escape Routes & Fire Spread
Sub Category	Ease of Use
Action Required	Obstructions should be removed from the escape routes in the following locations: Outside flat 5, 2nd floor. 12/10/2023 This task is outstanding.
Priority	Medium
Status	Identified
Owner	Neighbourhood Services
Due Date	6 September 2021

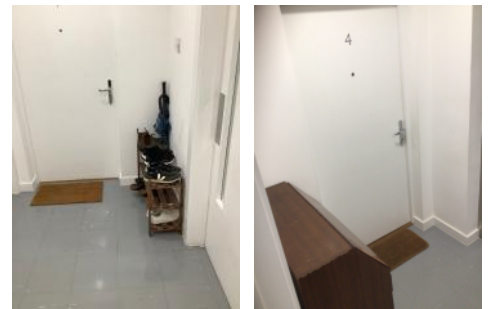
Task 8

Source Version	2
Category	Fire Prevention
Sub Category	Housekeeping
Action Required	The storage of combustible items in escape routes should be prohibited. 12/10/2023 This task is outstanding.
Priority	Medium
Status	Identified
Owner	Neighbourhood Services
Due Date	6 September 2021
