**Fire Risk Assessment**

**50 Wenlock Street**

Version 3

29 August 2023

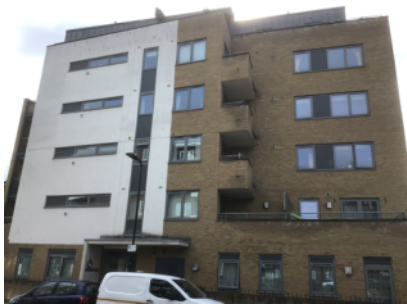
External walls on the front (northern) elevation

The external facade is mostly brick but a partial section appears appears to be a ‘Sto-render type wall system.

It is recommended to conduct an intrusive inspection of the external walls of this building to ensure they meet the requirements of the Building Regulations.

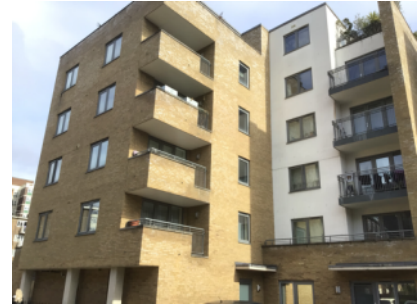
External walls on the western side elevation

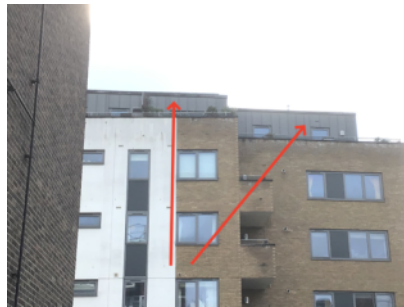
Photograph showing an identified external wall system on fifth floor

Also the upper floor (fifth floor) and a section of the fourth floor appears to have some form of metallic cladded external wall system fitted. It cannot be confirmed within the scope of this fire risk assessment the type and construction of this cladding nor its inner-insulating material. Also the substrate to which the render has been applied cannot be confirmed.

Source Version	1
Category	Escape Routes & Fire Spread
Sub Category	Construction and Glazing
Action Required	Carry out an intrusive survey of the external wall system to ascertain if it meets the current government guidance.
Priority	Medium
Status	Identified
Owner	Customer Homes
Due Date	24 September 2020

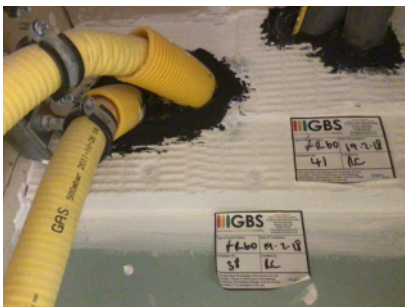
It is evident that a program of fire stopping has been conducted in riser cupboards in February of 2018.

Evidence of fire stopping within riser cupboards conducted in 2018

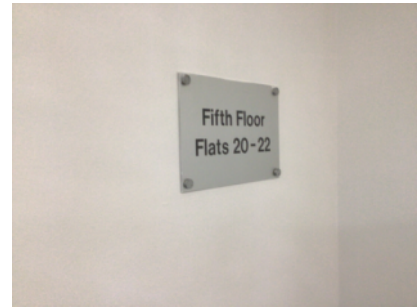
Floor numbers are identified both within the staircase and within outside the lift

Floor numbers identified on each floor level
