**Fire Risk Assessment**

**51-60 Quill Street**

Version 3

31 July 2023

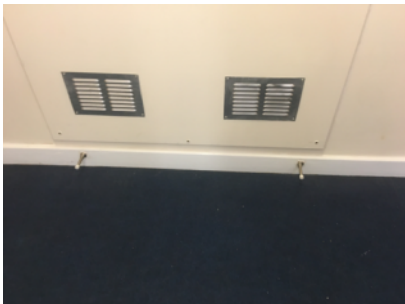
There are grill-vents installed in the enclosed (boarded) risers. It should be confirmed that these are intumescent grilles to ensure the required compartmentation is maintained.

Confirm grill-vents are intumescent protected

Source Version	1
Category	Escape Routes & Fire Spread
Sub Category	Construction and Glazing
Action Required	There are grill-vents installed in the enclosed (boarded) risers. It should be confirmed that these are intumescent grilles to ensure the required compartmentation is maintained.  If these are not intumescent grilles then these should be replaced with ones which are.
Priority	Medium
Status	Identified
Owner	Customer Homes
Due Date	23 December 2020

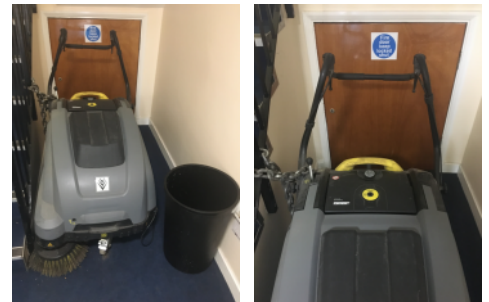
Source Version	1
Category	Fire Prevention
Sub Category	Housekeeping
Action Required	There is a large electrically powered floor cleaning machine located in the main entrance hallway which should be removed.
Priority	High
Status	Identified
Owner	Neighbourhood Services
Due Date	22 September 2020
