Fire Risk Assessment 54-62 Falmer Road, Walthamstow Version 5

13 September 2023

Review Date: 13 September 2024 Score: Tolerable Risk Assessor: Andy Harris

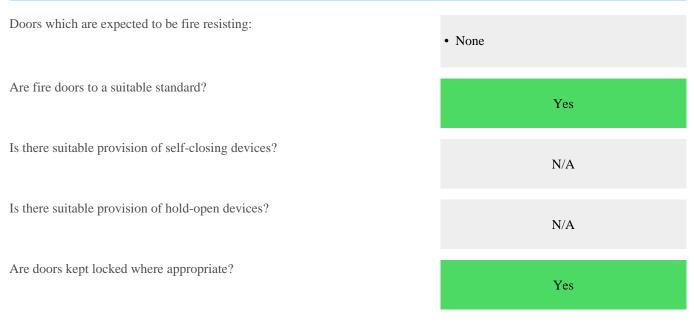
Fire Doors

It is understood that communal doors are inspected regularly by neighbourhood officers and formally recorded in the quarterly/6 monthly estate inspections with residents. Records are held with the neighbourhood officers. Flat entrance doors are inspected during the annual LGSR visits where the gas engineers record on their PDA if a door closer exists and intumescent strips and cold smoke seals exist.

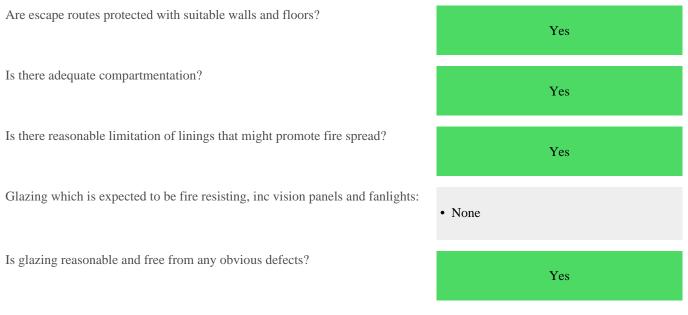
Construction & Glazing

It was not possible to access the roof space within the scope of this FRA. It should be confirmed there is adequate fire separation between flats, and between flats and the common parts in this area.
