Fire Risk Assessment

548 Forest Road, Walthamstow

Version 5

13 September 2023

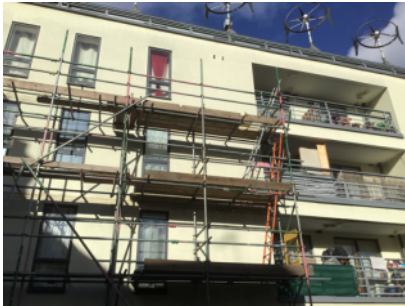
External wall - rear elevation

Rear elevation external wall is rendered, the substrate to which the render has been applied cannot be confirmed within the scope of this FRA.

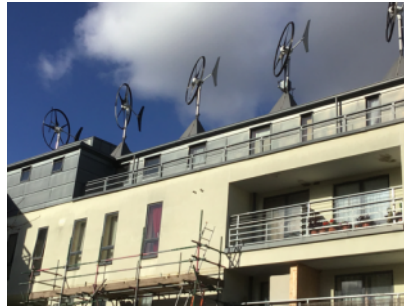
Unidentified wall cladding system on 4th floor

The top floor (4th floor) has some cladding installed. The cladding type, construction and standard of installation cannot be confirmed within the scope of this FRA.

Assessment of the fire risks of external walls and any cladding are excluded from the scope of this current fire risk assessment, as this is outside our expertise. (6) Accordingly, it is strongly recommended that you obtain advice from qualified and competent specialists on the nature of, and fire risks associated with, the external wall construction, including any cladding, of this building.

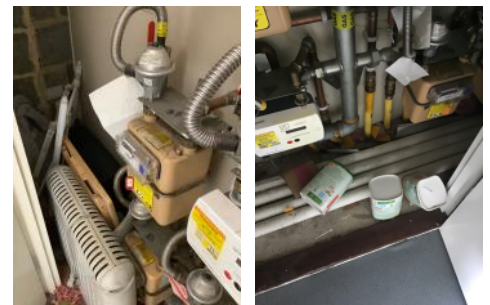
Task 6

Source Version	2
Category	Fire Prevention
Sub Category	Housekeeping
Action Required	The storage of combustible items in riser cupboards should be prohibited. A pram and other combustibles were found within the gas meter cupboard, ground floor. VERSION 4: It was noted that this remedial work, recommended in previous FRAs, has not been completed, 13/09/2023 This task remains outstanding
Priority	Medium
Status	Identified
Owner	Neighbourhood Services
Due Date	12 November 2020
