Fire Risk Assessment

63B 63C Richmond Road

Version 4

15 August 2023

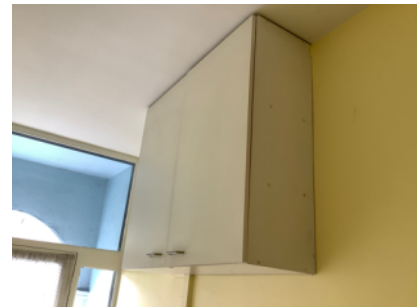
The electrical installations in the entrance hallway are not housed in a fire resisting enclosure and as such the existing enclosure should be upgraded or replaced to one which affords 30 minutes fire resistance with FD30S doors fitted.

Electrical cupboard is not FR.

The electrical cupboard on the ground floor has had some additional fire resisting material installed to the inside, however, it is doubtful that this would afford a 30 minute standard of fire resistance and therefore it is advised this be replaced.

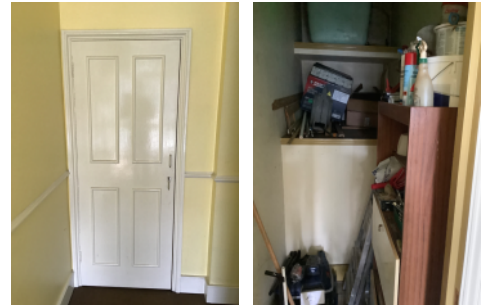
Task 5

Source Version	1
Category	Escape Routes & Fire Spread
Sub Category	Fire Doors
Action Required	VERSION 3: The following task, generated in the previous FRA, has not been completed and therefore remains as “identified” within this FRA: Replace the following doors with FD30S doors: Water cupboard door, ground floor. (This cupboard is being used for storage of combustible items, including paints and aerosols) 15/08/23 This task is still outstanding
Priority	Medium
Status	Identified
Owner	Customer Homes
Due Date	9 September 2020

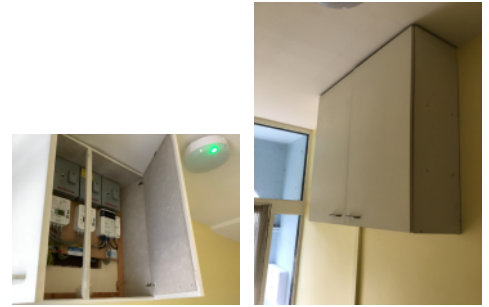
Task 6

Source Version	1
Category	Escape Routes & Fire Spread
Sub Category	Construction and Glazing
Action Required	<p>VERSION 3: The following task, generated in the previous FRA, has not been completed and therefore remains as “identified” within this FRA:</p> <p>Construct an enclosure affording FD30S standard of fire resistance in the following location:</p> <p>The electrical cupboard on the ground floor has had some additional fire resisting material installed to the inside, however, it is doubtful that this would afford a 30 minute standard of fire resistance and there is no intumescent strips or cold smoke seals fitted and therefore it is advised this be replaced.</p> <p>15/08/23 This task is still outstanding</p>
Priority	Low
Status	Identified
Owner	Customer Homes
Due Date	9 September 2021

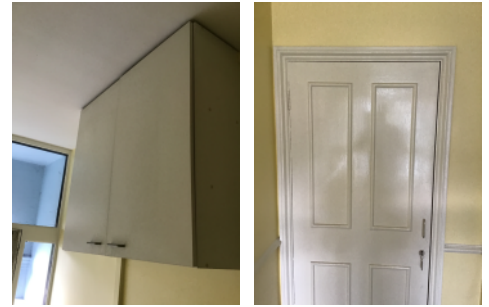
Task 7

Source Version	1
Category	Signs & Notices
Sub Category	Fire Door Signage
Action Required	VERSION 3: The following task, generated in the previous FRA, has not been completed and therefore remains as “identified” within this FRA:

Provide Fire Door Keep Locked Shut signs on the following doors:

Electrical cupboard doors
