Fire Risk Assessment

9-13 Canonbury Court

Version 4

29 August 2023

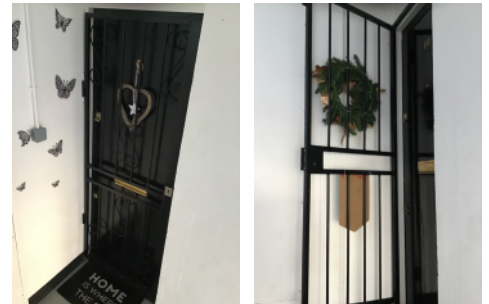
Task 1

Source Version	1
Category	Escape Routes & Fire Spread
Sub Category	Ease of Use
Action Required	There are security gates across the entrance doors to some flats. Residents should be advised of the dangers of locked security gates in the event of a fire to ensure that they are able to exit quickly in an emergency.
	29/08/23 This task is still outstanding.
Priority	Advisory
Status	Identified
Owner	Neighbourhood Services
Due Date	4 December 2022
