Fire Risk Assessment

Mandarin Wharf, Flats 1-25

Version 5

4 September 2023

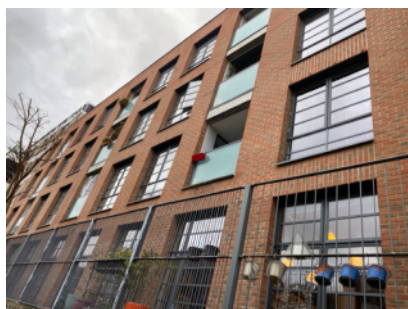
External walls – Rear elevation.

The external walls at the front elevation of the building are of brick/mortar construction on the ground, 1st and 2nd floor levels, as are the external walls at the rear elevation.

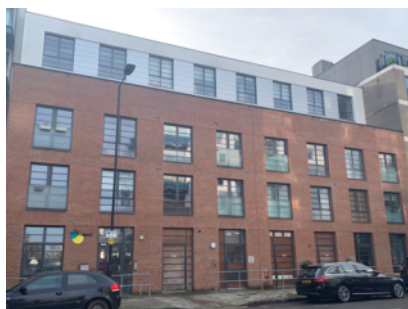
They have concluded that in the event of a fire, Wall Type 4 would be likely to result in the fire spreading within the external wall cavity or across the surface of the external wall. This wall type is found on the 3rd and 4th floors on the front facade only.

Front elevation, with unidentified external wall system on 3rd floor.

The third floor appears to have some cladded external wall system fitted. This could not be identified within the scope of this fire risk assessment.

Source Version	3
Category	Escape Routes & Fire Spread
Sub Category	Construction and Glazing
Action Required	CHPKFE consider that the following remedial works are required to the external walls to achieve an adequate level of safety: - Replacement of the ACM Cladding to the top two floors, - Installation of suitable and sufficient cavity barriers behind the same cladding.
Priority	High
Status	Identified
Owner	Customer Homes
Due Date	2 January 2022

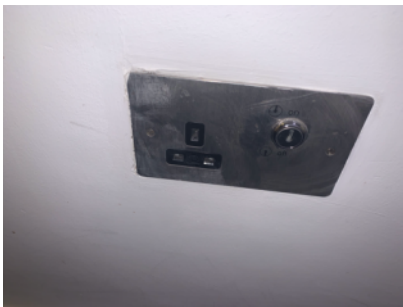
There are key operated electrical sockets in the common areas, presumably for use by cleaning staff. These were in good condition and showed no evidence of misuse by residents or visitors.

Key operated electrical sockets in common corridors

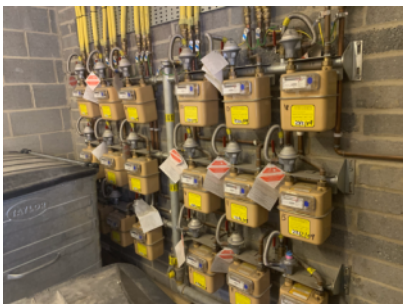
No

Gas meters located in bin store.

Source Version	1
Category	Fire Prevention
Sub Category	Gas
Action Required	Provide a barrier for the gas meters in the following locations to prevent against accidental damage: Gas meters provided within the bin store. Version 4 - 17/11/21 This task is still outstanding.
Priority	Medium
Status	Identified
Owner	Customer Homes
Due Date	14 January 2021

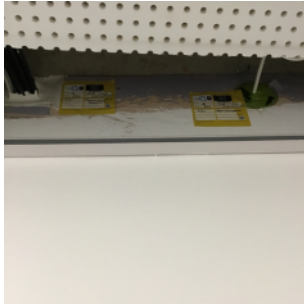
It is apparent that there are numerous pipe and cable penetrations into these flats from the common corridor that have no fire stopping installed. Fire stopping should be installed and it is recommended that a full fire stopping survey is undertaken throughout the building to ensure there is adequate compartmentation provided to support the stay-put policy which is in place.

Version 4 - the fire stopping above flats 15 and 16 has been completed.

Version 4 - 17/11/21 evidence of fire stopping above flat 15

Source Version	1
Category	Escape Routes & Fire Spread
Sub Category	Construction and Glazing
Action Required	It is recommended to conduct a full fire stopping survey of this building to ensure there is adequate fire stopping to support the stay-put policy in place.
Priority	Medium
Status	Identified
Owner	Customer Homes
Due Date	14 January 2021
