Fire Risk Assessment

278 Forest Rd, Flats 1-10

Version 4

13 September 2023

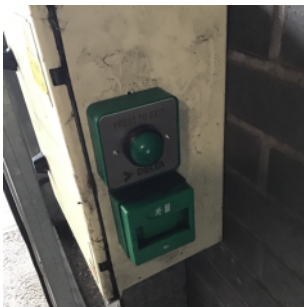
Version 3 - The key opening mechanism on the car park gate has been replaced with a mushroom button device.

New mushroom button device

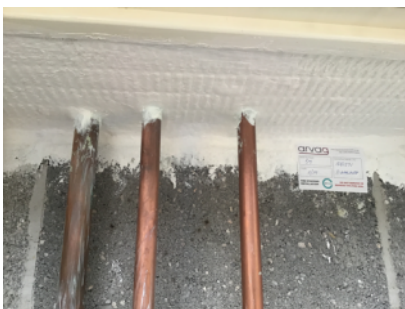
It is evident that a recent programme of fire stopping has been undertaken in this building (11/19), to an acceptable standard. However, whilst some cable penetrations have been fire stopped within the electrical cupboard on the ground floor, there is a large hole in the corner where a number of cables pass which is not adequately fire stopped.

Evidence of recent fire stopping.

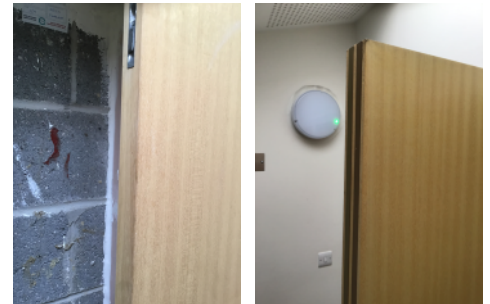
Task 1

Source Version	1
Category	Escape Routes & Fire Spread
Sub Category	Fire Doors
Action Required	Replace the intumescent strips with combined intumescent strips and smoke seals on the following doors: There are fire resisting double-doors installed to risers. These have intumescent strips and cold smoke seals installed around the frame edges, however, there is no cold smoke seal (intumescent strip only) installed in the centre gap. VERSION 2: The remedial work recommended in task from the previous FRA has not been completed Version 3 - This task is still outstanding 13/09/2023 This task is still outstanding.
Priority	Low
Status	Identified
Owner	Customer Homes
Due Date	14 November 2021

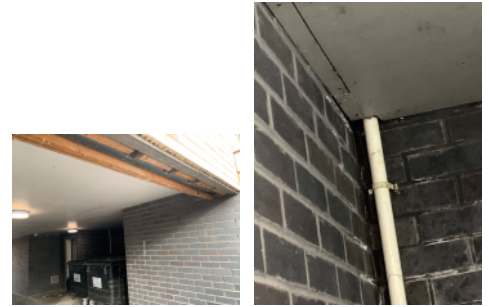
Task 5

Source Version	1
Category	Escape Routes & Fire Spread
Sub Category	Construction and Glazing
Action Required	<p>Common bin/skips are located in the undercroft entrance to the rear carpark. There are penetrations in the ceiling into the building above which should be fire stopped, as any fire plume from a fire in a refuse receptacle of this size would undoubtedly affect the entire surface of this ceiling area.</p> <p>VERSION 2: The remedial work recommended in task from the previous FRA has not been completed</p> <p>Version 3 - This task is still outstanding</p> <p>13/09/2023 This task is still outstanding.</p>
Priority	High
Status	Identified
Owner	Customer Homes
Due Date	13 February 2020

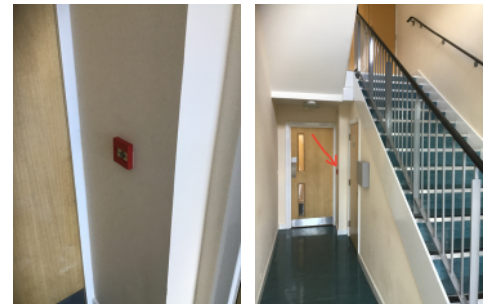
Task 8

Source Version	2
Category	Signs & Notices
Sub Category	Other Signage
Action Required	Provide signage to confirm the operation of smoke vent controls.
	Version 3 - This task is still outstanding
	13/09/2023 This task is still outstanding.
Priority	Low
Status	Identified
Owner	Neighbourhood Services
Due Date	2 November 2021
