Fire Risk Assessment

Holden House

Version 3

5 October 2023

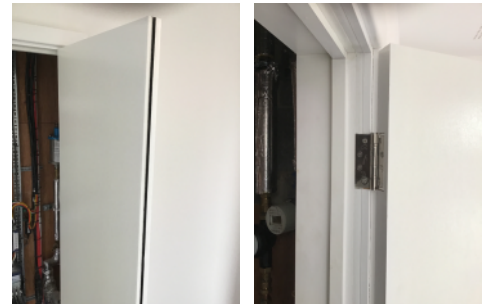
Task 1

Source Version	1
Category	Escape Routes & Fire Spread
Sub Category	Fire Doors
Action Required	Replace the intumescent strips with combined intumescent strips and smoke seals on the following doors: Cold smoke seals are only fitted to the centre gap of the gas/electrical riser cupboard doors. Cold smoke seals should be fitted to protect all gaps around these doors.
Priority	Low
Status	Identified
Owner	Customer Homes
Due Date	2 October 2021

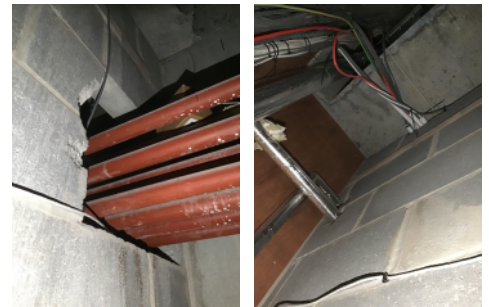
Task 3

Source Version	1
Category	Escape Routes & Fire Spread
Sub Category	Construction and Glazing
Action Required	Provide fire stopping around pipe penetrations in the following locations: Within the electrical, gas riser cupboard on the ground floor, there are large penetrations made by gas pipes and cables passing through compartment walls into the cupboard.
Priority	High
Status	Identified
Owner	Customer Homes
Due Date	3 April 2020

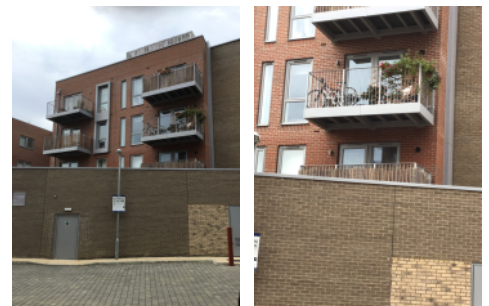
Task 4

Source Version	1
Category	Fire Prevention
Sub Category	Housekeeping
Action Required	Residents should be advised about the risks arising from the presence of combustibles materials on balconies
Priority	Advisory
Status	Identified
Owner	Neighbourhood Services
Due Date	2 October 2022
