Fire Risk Assessment

143 Alfred Wallis House

Version 5

26 September 2024

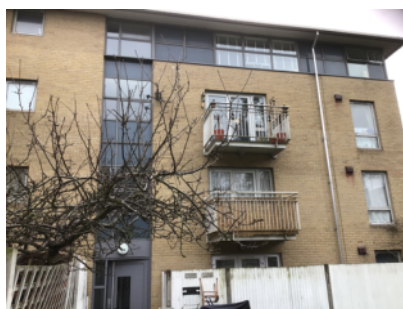
External walls – rear elevation.

The external facade (both front and rear elevations) of the building appears to be of brick/mortar construction.

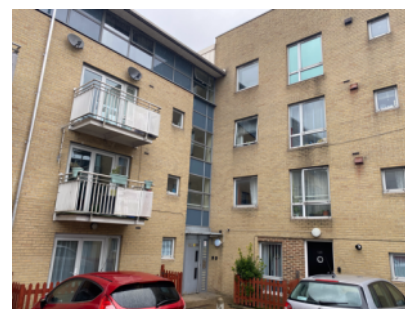
External walls - front elevation
