**Fire Risk Assessment**

**289 Amhurst Road**

Version 5

17 October 2024

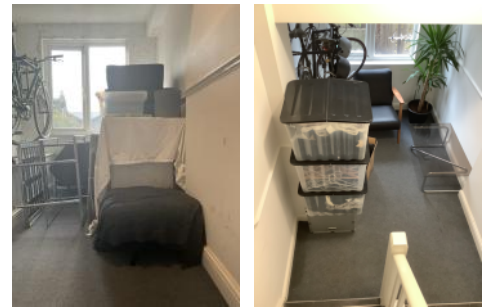
## Task 6

Source Version	2
Category	Escape Routes & Fire Spread
Sub Category	Ease of Use
Action Required	The first half-landing now contains an unacceptable amount of combustibles and items which would cause an obstruction to escaping persons in the event of a fire.
	Version 5. 17/10/24 This task remains outstanding.
Priority	High
Status	Identified
Owner	Neighbourhood Services
Due Date	15 March 2022
