Fire Risk Assessment 49 A-B Davenant Road

Version 4

13 September 2024

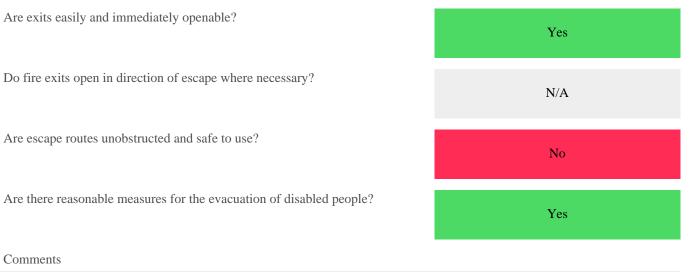
The provision of thumb turn devices on final exits means the doors can be opened without the use of a key.

Source Version	1
Category	Escape Routes & Fire Spread
Sub Category	Ease of Use
Action Required	Obstructions should be removed from the escape routes in the following locations:
	Entrance hallway and staircase.
	Version 3. 13/9/24 Remains outstanding
Priority	High
Status	Identified
Owner	Neighbourhood Services
Due Date	31 August 2020

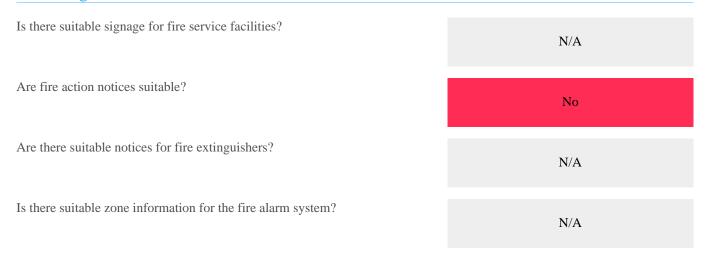
Provide fire action notices which confirm the action to take in the event of fire.

Source Version	1
Category	Signs & Notices
Sub Category	Other Signage
Action Required	Provide fire action notices which confirm the action to take in the event of fire.
	Version 3. 13/9/24 Remains outstanding
Priority	Medium
Status	Identified
Owner	Neighbourhood Services
Due Date	01 December 2020
