Fire Risk Assessment

200 Kingsland Road

Version 4

11 September 2024

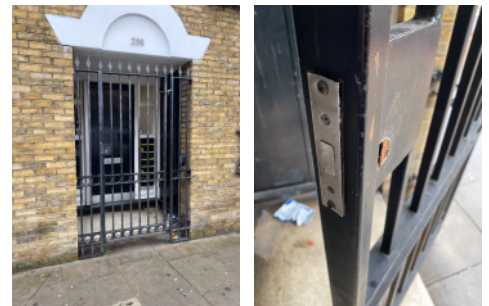
Task 6

Source Version	1
Category	Escape Routes & Fire Spread
Sub Category	Ease of Use
Action Required	Of concern is a security gate fitted externally across the main entrance door. This gate has a mortice lock fitted. The lock should be removed, or replaced with a thumb turn device which will ensure persons are able to escape from the building at all times without the use of a key. Version 4. 11/9/24 Lock remains
Priority	High
Status	Identified
Owner	Customer Homes
Due Date	27 January 2021
