## **Fire Risk Assessment**

### **1-16 Portfleet Place**

Version 5

30 August 2024

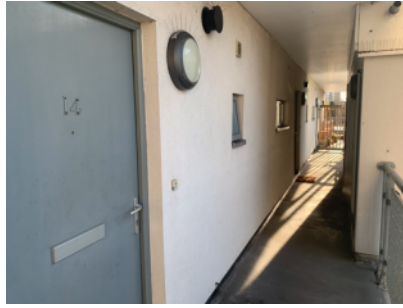
There is window glazing to flats along common balconies, however, these are above 1.1m and are therefore not required to be fire resisting.

Showing window glazing to flats - above 1.1m
