## **Fire Risk Assessment**

## **39 Provost Street**

Version 4

## 27 August 2024

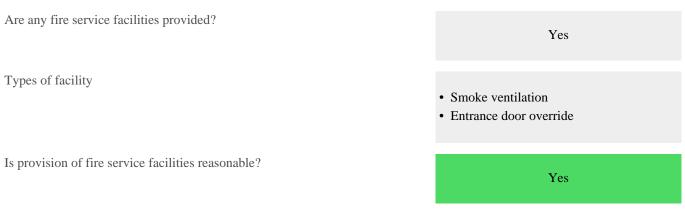
The entrance door fire service override is located at high-level in the wall and could not be tested.

It is recommended that the building contains a premises information box that includes a copy of up-to-date floor plans, as well as information about any lift intended for use by fire and rescue services

It is recommended that floor numbers are clearly identified at each level.

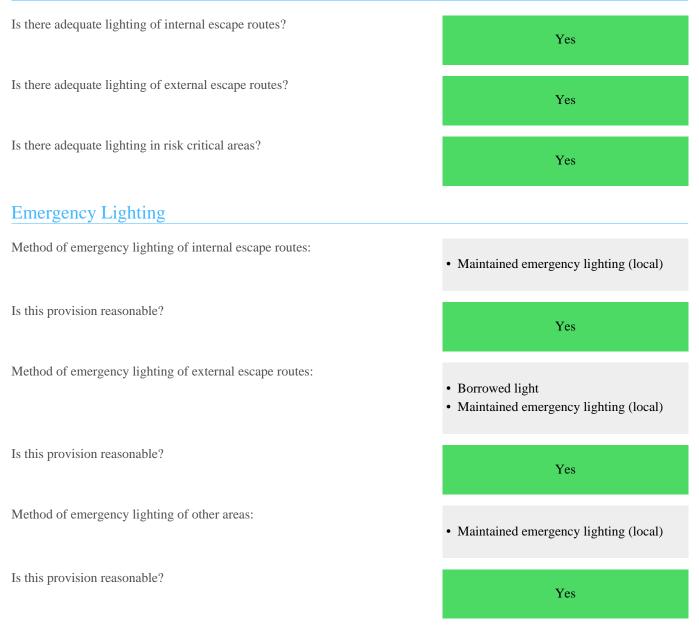
Engineer was on site at the time of this inspection to conduct the annual test on the emergency lighting system.

Maintained emergency lighting in the staircase.

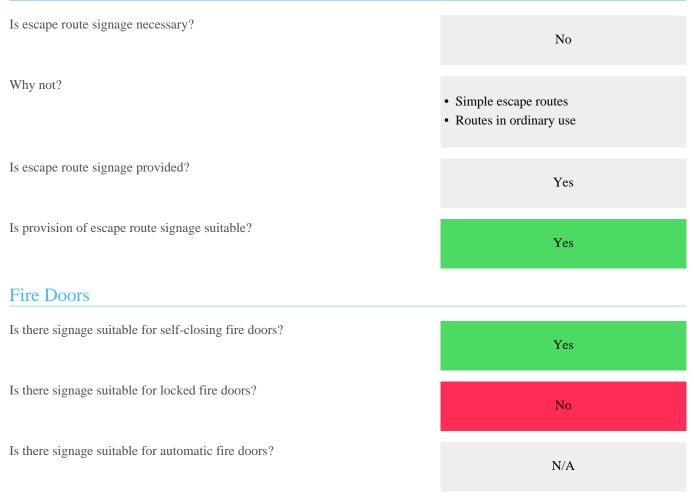
All riser cupboards should be fitted with "Fire Door Keep Locked" signage.
