**Fire Risk Assessment**

**51-60 Quill Street**

Version 4

12 August 2024

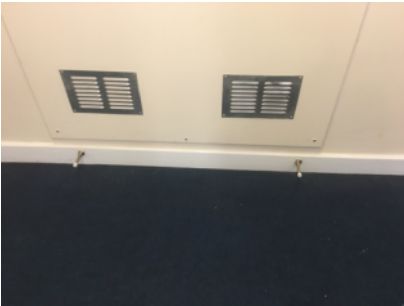
There are grill-vents installed in the enclosed (boarded) risers. It should be confirmed that these are intumescent grilles to ensure the required compartmentation is maintained.

Confirm grill-vents are intumescent protected

Source Version	1
Category	Escape Routes & Fire Spread
Sub Category	Construction and Glazing
Action Required	<p>There are grill-vents installed in the enclosed (boarded) risers. It should be confirmed that these are intumescent grilles to ensure the required compartmentation is maintained.</p> <p>If these are not intumescent grilles then these should be replaced with ones which are.</p> <p>Version 4, 12/08/2024: This task remains outstanding.</p>
Priority	Medium
Status	Identified
Owner	Customer Homes
Due Date	23 December 2020
