Fire Risk Assessment

16 Summerhill Rd

Version 5

11 September 2024

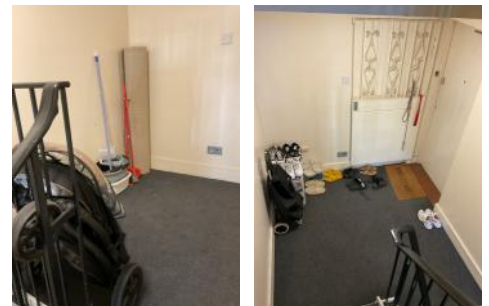
Task 2

VERSION 2: This task has not been completed and a number of items remain in this location, indeed, the number of items has increased since the last FRA. (Second photograph)

Version 4, 11/09/2024
The amount of items has increased further. This task remains outstanding.
