Fire Risk Assessment

36-38 Trays Hill Close

Version 3

20 September 2024

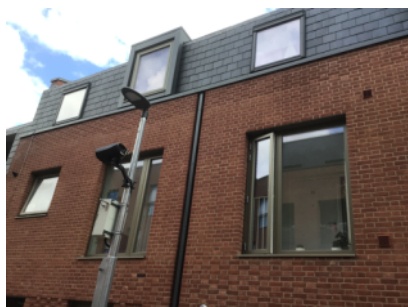
Brick/mortar construction, with tiled facade on second floor

External walls rear elevation

External walls are predominantly brick and mortar construction, with the exception of a section of tiled facade on the second floor.
