**Fire Risk Assessment**

**4 Tufnell Park Road**

Version 4

26 September 2024

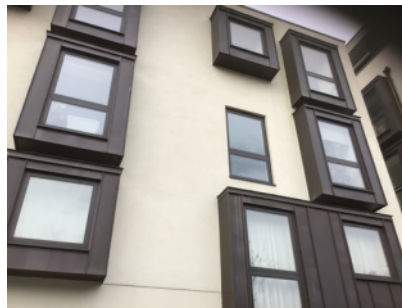
External walls - front elevation

The external facade appears to be a render over insulation board.

There is a metallic rain screen covering sections of the front face of the building and around window openings.

There is some decorative gridwork which appears to be of timber construction attached to the external facade of the third and fourth floors

Whilst this building is not over 18 m, it should be considered to conduct an intrusive examination of the external walls to ensure that they meet the requirements of the building regulations regarding external fire spread.
