**Fire Risk Assessment**

**18-23 Wilton Place**

Version 4

16 August 2024

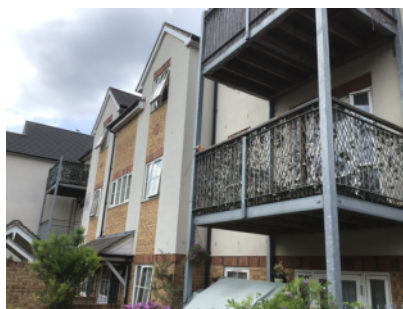
External walls, end elevation

Masonry external walls (part rendered)

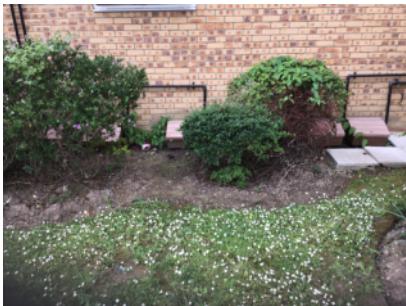
Gas meters are located externally and not in common areas.

Gas meters located externally

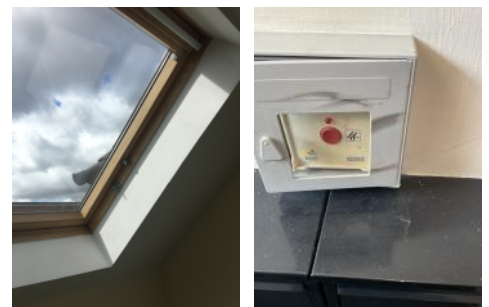
### Task 4

The velux type window AOV on the 2nd floor appears to have no opening mechanism. The smoke ventilation was tested via a the ground floor manual actuator, however no AOVs operated in the common staircase. The system should be tested as soon as possible and repaired as necessary to ensure it is fully operational at all times.

Window AOV appears defective

| 4 | Escape Routes & Fire Spread | Smoke Ventilation | <p>Repair the smoke vents in the following locations:</p> <p>All Window AOVs in staircase.</p> <p>Version 4, 16/08/2024<br/>Unable to ascertain if completed. The control panel is flashing a warning. This task remains outstanding.</p> | Critical | Identified |

| Action Required | Repair the smoke vents in the following locations:<br><br>All Window AOVs in staircase. |
