Fire Risk Assessment

Robinson Court

Version 4

7 September 2023

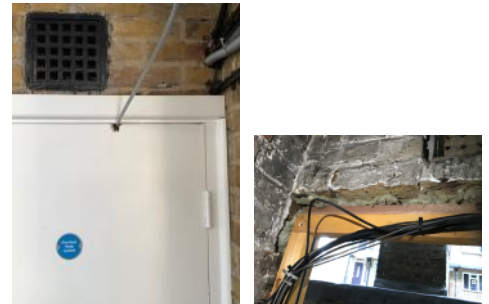
Task 1

Source Version	1
Category	Escape Routes & Fire Spread
Sub Category	Construction and Glazing
Action Required	Provide fire stopping around the door frame at the following locations: There is a newly fitted door to the intake cupboard, however, it has not been properly fire stopped around the frame. 07/09/2023 This task is still outstanding.
Priority	Medium
Status	Identified
Owner	Customer Homes
Due Date	7 January 2021

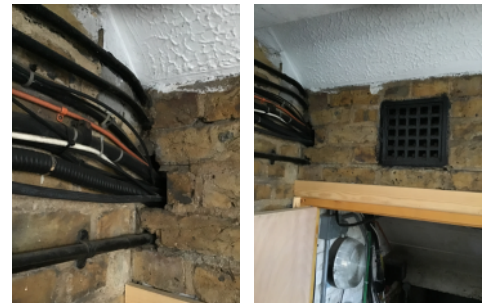
Task 2

Source Version	1
Category	Escape Routes & Fire Spread
Sub Category	Construction and Glazing
Action Required	Provide fire stopping at the following locations: There are cable penetrations, and a vent/grill above both the doors to both of the electrical cupboards which should be fire stopped. VERSION 2: It was not possible to access this cupboard to confirm if the recommended remedial work has been completed. 07/09/23 This task is still outstanding.
Priority	Medium
Status	Identified
Owner	Customer Homes
Due Date	7 January 2021

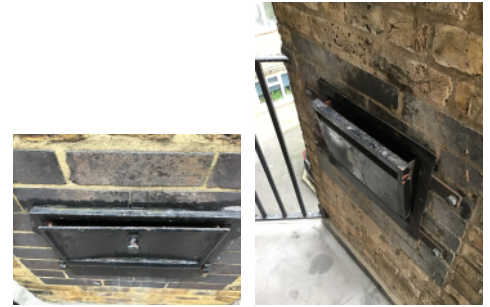
Task 3

There is a rubbish chute provided, however, the hatches are old, rusted and in a poor state of repair and would not afford the required 30 minutes fire resistance.

Source Version	1
Category	Escape Routes & Fire Spread
Sub Category	Dampers, Ducts and Chutes
Action Required	Repair the refuse chute hatches in the following locations, to afford 30 minutes of fire resistance: There is a rubbish chute provided, however, the hatches are old, rusted and in a poor state of repair and would not afford the required 30 minutes fire resistance. 07/09/2023 This task is still outstanding.
Priority	Low
Status	Identified
Owner	Customer Homes
Due Date	7 January 2022

3	Escape Routes & Fire Spread	Dampers, Ducts and Chutes	<p>Repair the refuse chute hatches in the following locations, to afford 30 minutes of fire resistance:</p> <p>There is a rubbish chute provided, however, the hatches are old, rusted and in a poor state of repair and would not afford the required 30 minutes fire resistance.</p> <p>07/09/2023 This task is still outstanding.</p>	Low	Identified
4	Escape Routes & Fire Spread	Ease of Use	<p>Obstructions should be removed from the escape routes in the following locations:</p> <p>All balconies had varying quantities of items which may cause an obstruction/trip hazard for escaping occupants.</p> <p>07/09/2023 This task is still outstanding.</p>	Low	Identified
5	Emergency Lighting	Emergency Lighting	<p>Confirm the emergency lighting system is fully operational, with back up battery as required.</p> <p>Emergency lighting is provided in the staircases and on balconies, however, there appears to be numerous lighting units which are not showing a charging light.</p> <p>07/09/2023 This task is still outstanding.</p>	Medium	Identified

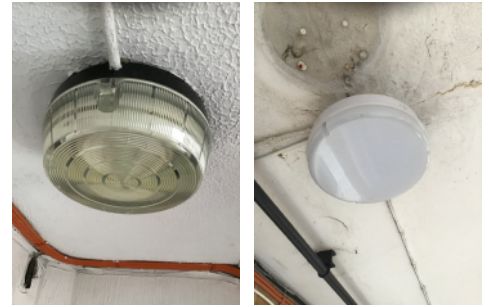
Task 5

Source Version	1
Category	Emergency Lighting
Sub Category	Emergency Lighting
Action Required	Confirm the emergency lighting system is fully operational, with back up battery as required.

Emergency lighting is provided in the staircases and on balconies, however, there appears to be numerous lighting units which are not showing a charging light.

07/09/2023
This task is still outstanding.
