Fire Risk Assessment

St Katharine's House

4 September 2023

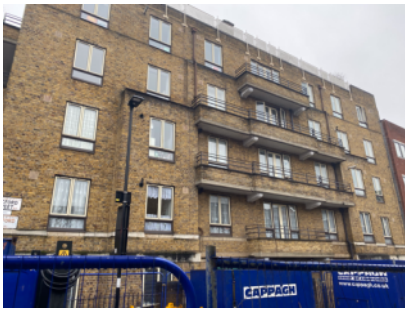
On the front elevation there are steel pillars which have are clad in an unidentified insulating material.

It cannot be confirmed within the scope of this fire risk assessment whether these pillars are considered to be elements of structure of the building, or whether this material has been added to provide protection to the steel pillars in the event of a fire. It was noted that this material has degraded exposing this the steel in some areas.

Rear elevation (Eckford St elevation)

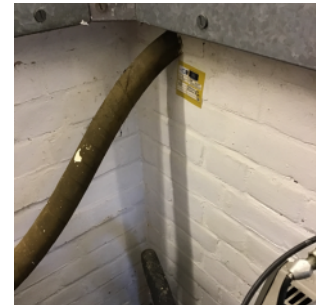
Version 3 - Evidence of fire stopping in lift motor room

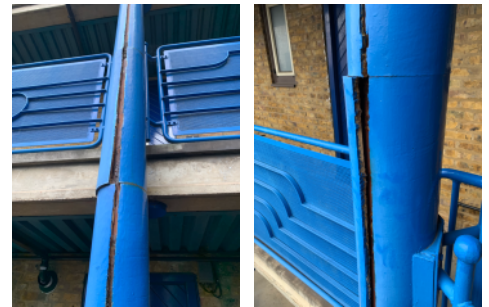
The insulating material over the structural steel pillars supporting balconies has degraded, exposing the steel pillars within. These appear to have severe water damage. It's advised to have structural engineer inspect these structural elements to ensure they perform as would be expected if exposed to fire.

Photograph showing degraded insulating material around structural steels.

Source Version	1
Category	Escape Routes & Fire Spread
Sub Category	Construction and Glazing
Action Required	The insulating material over the structural steel pillars supporting balconies has degraded, exposing the steel pillars within. These appear to have severe water damage. It's advised to have structural engineer inspect these structural elements to ensure they perform as would be expected if exposed to fire.
Priority	Advisory
Status	Identified
Owner	Customer Homes
Due Date	7 January 2023
