Fire Risk Assessment Willow Tree Court Version 3

13 September 2023

Review Date: 13 September 2024 Score: Tolerable Risk Assessor: Andy Harris

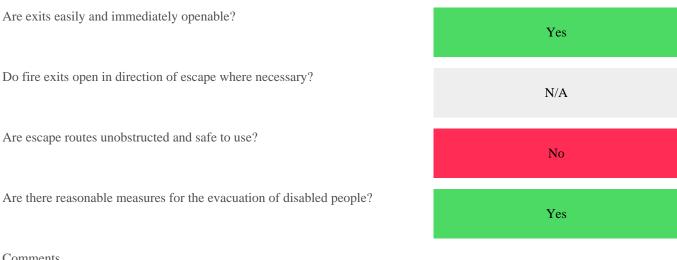
Emergency exit devices are provided which were tested at the time of this inspection and functioned correctly.

Obstructions should be removed from the escape routes, 1st floor landing.

Source Version	1
Category	Escape Routes & Fire Spread
Sub Category	Ease of Use
Action Required	Obstructions should be removed from the escape routes in the following locations:
	1st floor landing
	Version 2 - This task is still outstanding.
	13/09/2023
	This task is still outstanding.
Priority	High
Status	Identified
Owner	Neighbourhood Services
Due Date	23 November 2020
