**Fire Risk Assessment**

**20 and 20A Ainsworth Road**

Version 4

22 September 2021

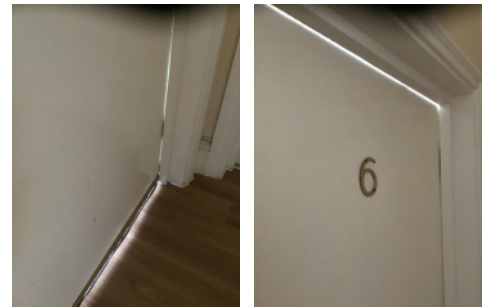
14	Escape Routes & Fire Spread	Fire Doors	VERSION 4: TASK NOT COMPLETED	Medium	Identified
			Re-hang the following doors to reduce the gaps around the doors:		
			External examination only of the door to Room 6 revealed it does not fit the frame correctly, with excessive gaps showing.		
			VERSION 3: The remedial work recommended in previous versions of this Fire Risk Assessment has not been completed.		
			VERSION 4: The remedial work recommended in previous versions of this Fire Risk Assessment has not been completed.

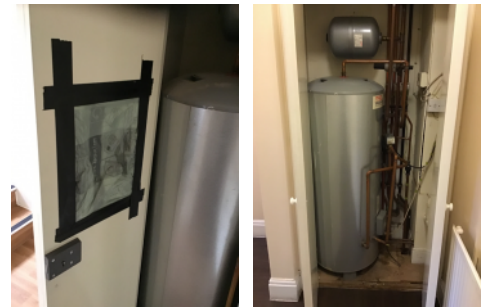
VERSION 2: This task has been remedied by cutting out the inner face of the door, allowing the door to close. However, in doing this it has severely compromised the fire resistance of this door. This door should now be replaced (to FD30S) and the whole cupboard extended in order to accommodate the boiler/immersion correctly.

VERSION 4: The remedial work recommended previous versions of this Fire Risk Assessment has not been completed.

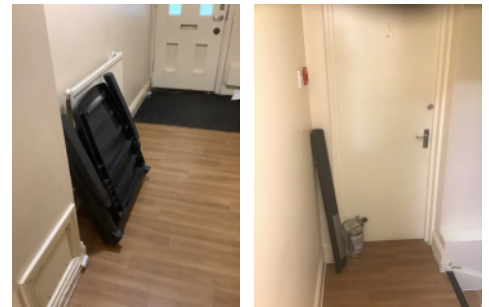
Source Version	2
Category	Fire Prevention
Sub Category	Housekeeping
Action Required	Although the amount of combustibles currently in escape routes is not unreasonable, routes should be monitored to ensure the amount of items does not build-up.
Priority	Low
Status	Identified
Owner	Neighbourhood Services
Due Date	8 October 2021
