**Fire Risk Assessment**

**50 Acton Mews**

Version 7

1 December 2022

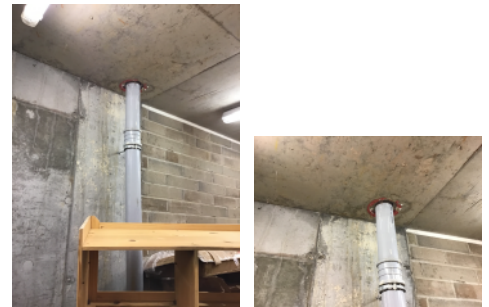
## Task 9

Source Version	1
Category	Escape Routes & Fire Spread
Sub Category	Construction and Glazing
Action Required	Provide fire stopping around pipe penetrations in the following locations:
