Fire Risk Assessment

37-80 Repton House

Version 7

7 August 2023

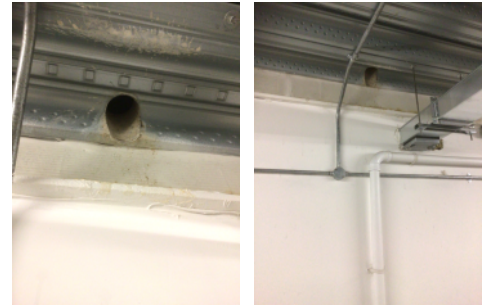
Task 5

Source Version	5
Category	Escape Routes & Fire Spread
Sub Category	Construction and Glazing
Action Required	Provide fire stopping around pipe penetrations in the following locations: Penetration through ceiling within the bike store.
Priority	Low
Status	Identified
Owner	Customer Homes
Due Date	6 April 2022
