### **Fire Risk Assessment**

### **Beaver House**

Version 3

3 October 2023

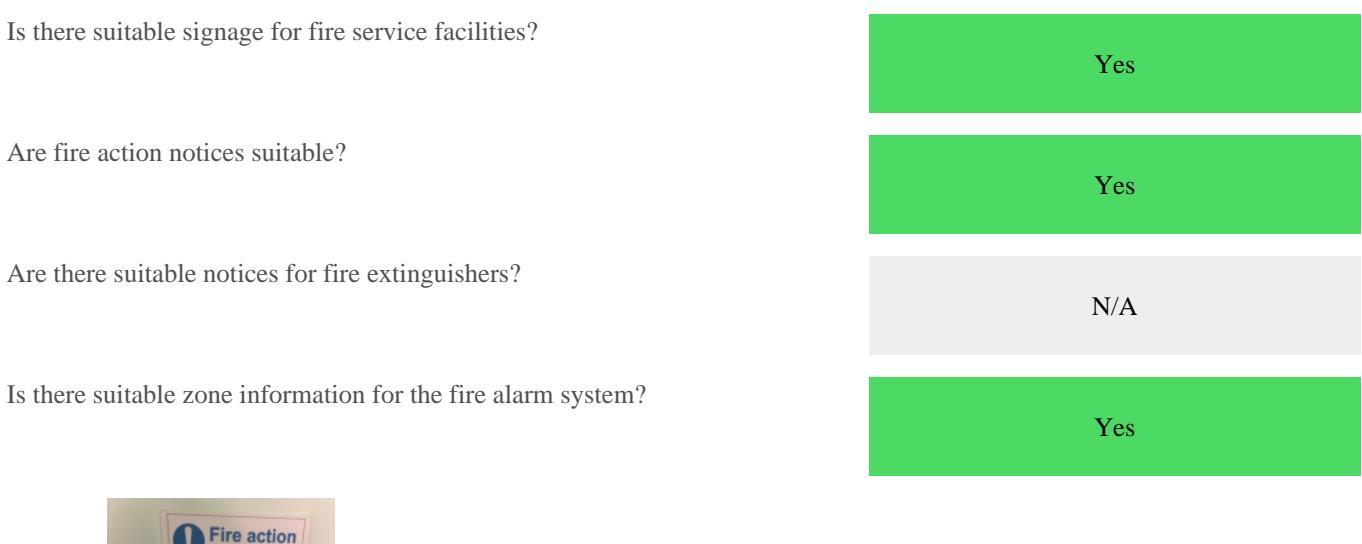
Example of the provided fire action notices
