**Fire Risk Assessment**

**1-10 Trays Hill Close**

Version 4

2 October 2023

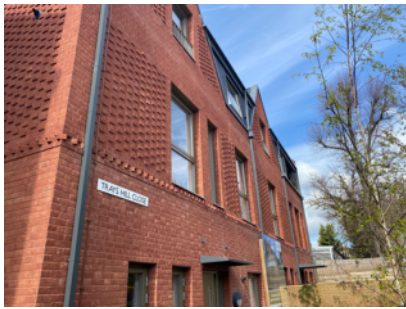
External walls front elevation

Attention is drawn to the Ministry of Housing, Communities & Local Government Consolidated Advice Note for building owners of multi-storey, multi-occupied residential buildings, dated January 2020. The Advice Note recommends that building owners should consider the risk of external fire spread as part of the fire risk assessment for multi-occupied residential buildings. Consideration has been given to this matter within this fire risk assessment. The Advice Note further recommends the assessment of the fire risks of any external wall system, irrespective of the height of the building.
