# PLAY AREA SAFETY INSPECTION REPORT

# Islington & Shoreditch Housing Association (ISHA)

# 03 May 2018

Site Owner :	Islington & Shoreditch Housing Association (ISHA)
Site Name :	ISHA - 548-558 Forest Road
Date of Inspection :	03 May 2018
Inspected by :	David Owen

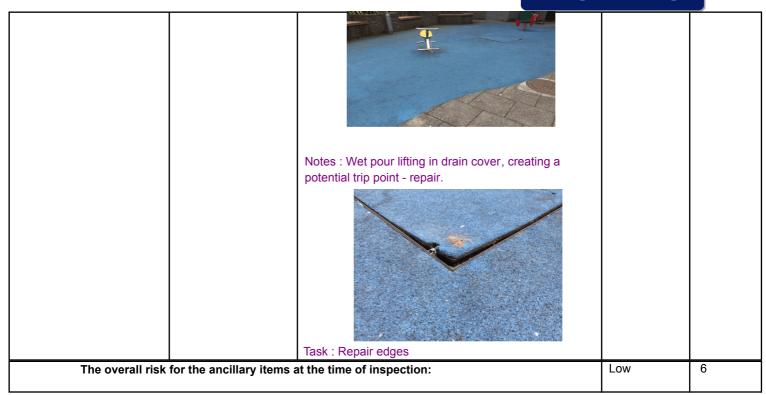
Facilities				
Lamppost	Lighting	Satisfactory		
Risk Score : Risk Level :				
Planters & Seats	Seating	Satisfactory		
Risk Score: 3 Risk Level: Very Low				
Site				
Security Entrance	Security	Satisfactory		
Risk Score : Risk Level :				
Surface	I		l l	1
General Surface - Concrete	General Surface	Satisfactory		
Risk Score: 3 Risk Level: Very Low				
General Surface - Wet Pour	General Surface	Finding : Surface - Edges Shrunk	Low	6
Risk Score: 3 Risk Level: Very Low				
			Generated by :
